**ADDENDUM TO BID
319 CEDAR ST, 431 & 501 S. MAIN ST DEMOLITIONS
BID NO.: 1216-PW-137**

ADDENDUM NO.: 1

Re: Preliminary Asbestos Inspection, 431 S. Main Street, Rockford, IL

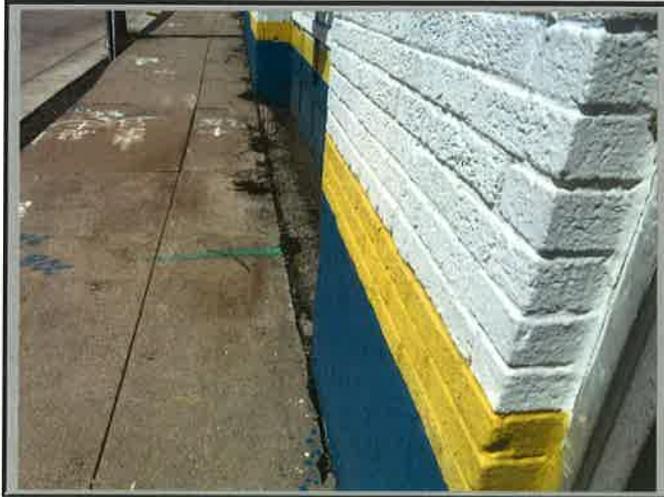
Photo 1

- Brick and mortar
- Plaster over terra cotta brick
- Wall tile mastic
- Window glazing
- Exterior caulk
- Red terrazzo
- Green terrazzo
- Plaster on brick
- Concrete block mortar

Brick and mortar

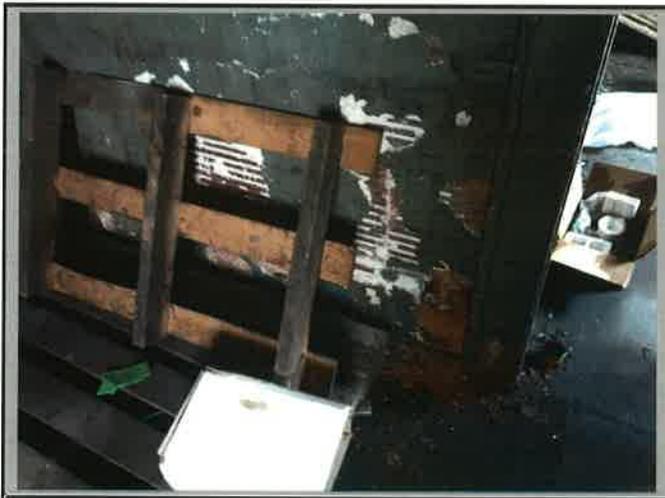
Photo 2

Plaster over terra cotta brick

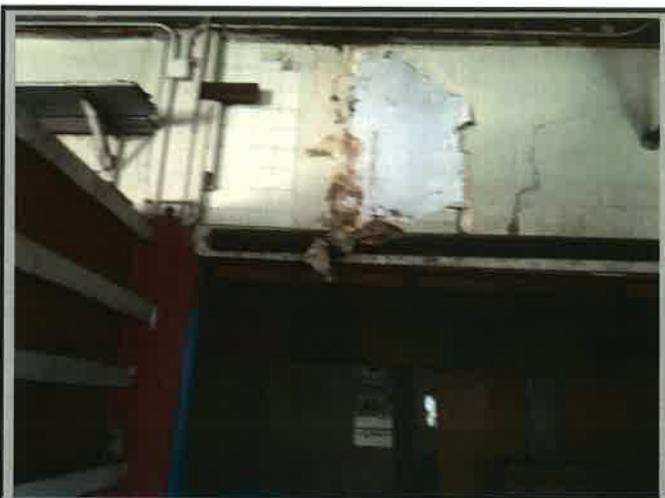
Photo 3

Wall tile mastic

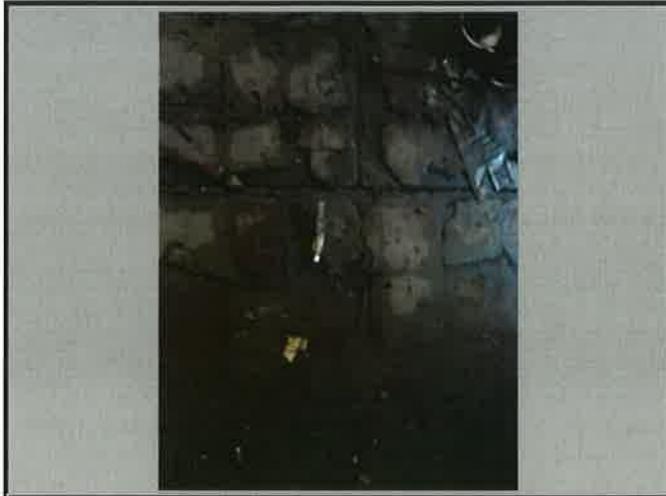
Photo 4

- Roofing, assumed
- Grey 9" x 9" floor tile (8% chrysotile by PLM) with non-ACM black mastic – southeast corner of building over black 9" x 9" floor tile (3% Chrysotile) with non-ACM black mastic
- Red 9" x 9" floor tile (3% Chrysotile by PLM) with non-ACM black mastic – southeast corner of the building over black 9" x 9" floor tile (3% Chrysotile) with non-ACM black mastic
- Light green 9" x 9" floor tile (2% Chrysotile by PLM) with non-ACM black mastic – office in southeast corner of the building

Grey 9" x 9" floor tile and mastic (double layer)

*Please Note: non-friable asbestos containing materials in **good** condition that fall under Category I, such as flooring and/or mastics on wood substrate and roofing materials are not **required** to be removed prior to demolition per the USEPA 40 CFR Part 61 National Emissions Standards for Hazardous Air Pollutants (NESHAP); Final Rule, dated November 20, 1990. However, while demolition is being performed the material must be kept wet and all debris must go to an approved landfill that accepts demolition debris and does not burn, crush, grind or recycle the material. In addition, you must have a trained individual knowledgeable in the provisions of 40 CFR Part 61, Subpart M, on site during the demolition and available for inspection during normal business hours. If material becomes damaged or rendered friable during demolition, proper abatement procedures must immediately be instituted.*

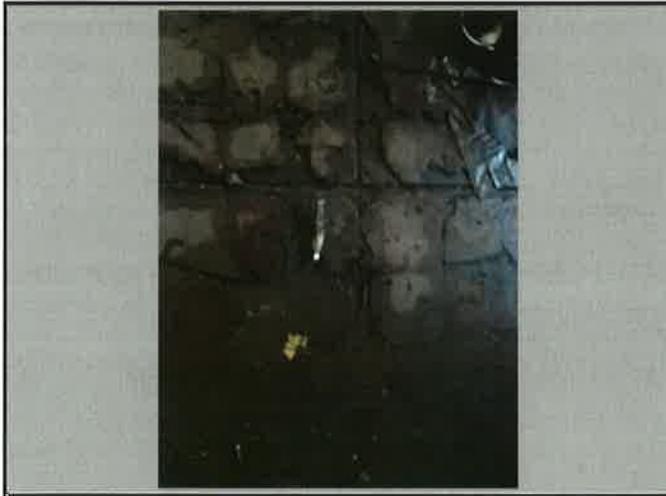
Photo 5

Red 9" x 9" floor tile and mastic (double layer)

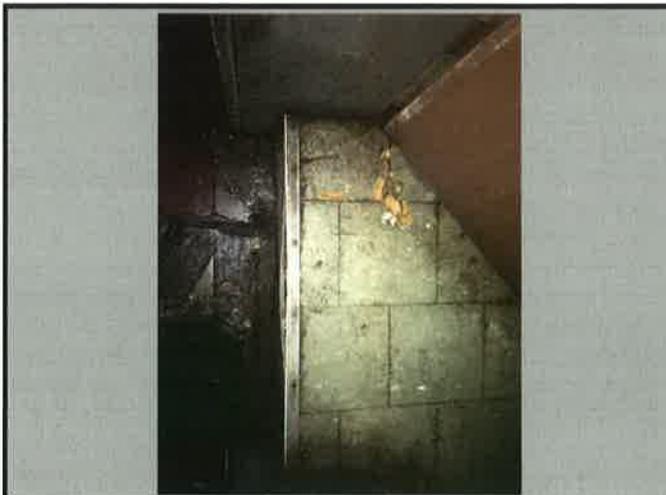
Photo 6

Light green 9" x 9" floor tile and mastic

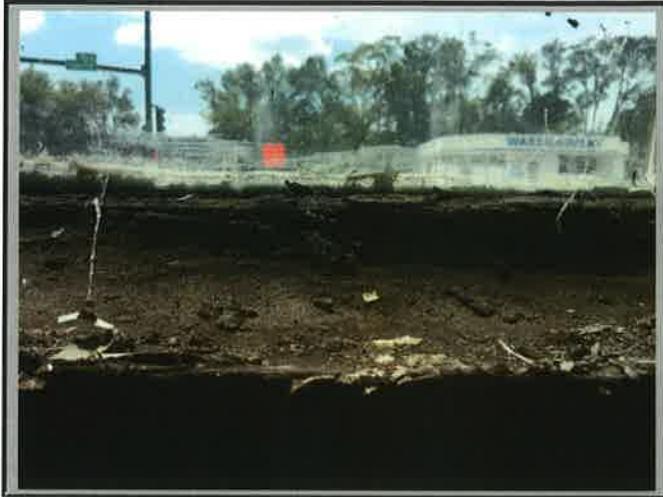
Photo 7

Window glazing

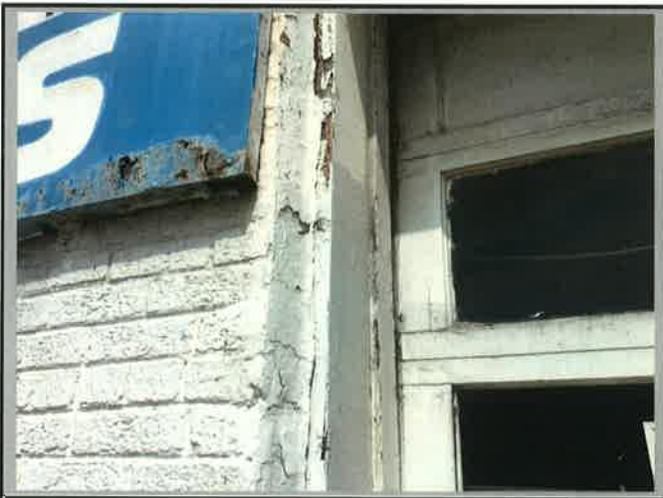
Photo 8

Exterior caulk

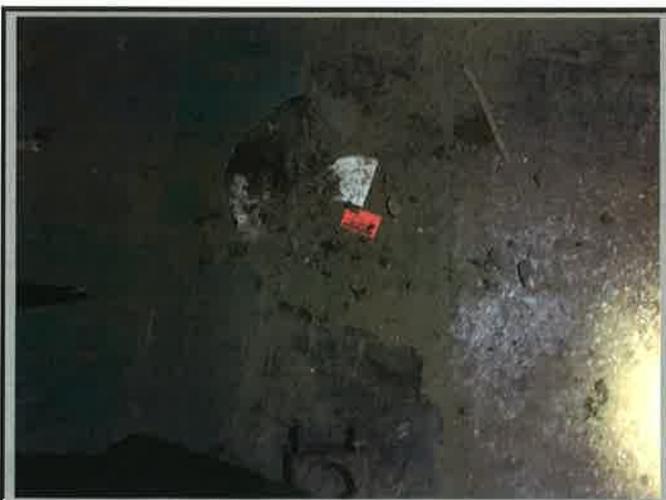
Photo 12

- Dark green 9" x 9" floor tile (5% chrysotile by PLM) with ACM black mastic (10% chrysotile by PLM) – east part of building
- Dark brown 9" x 9" floor tile (5% chrysotile by PLM) with ACM black mastic (10% chrysotile by PLM) – east part of building

Dark green 9" x 9" floor tile and mastic

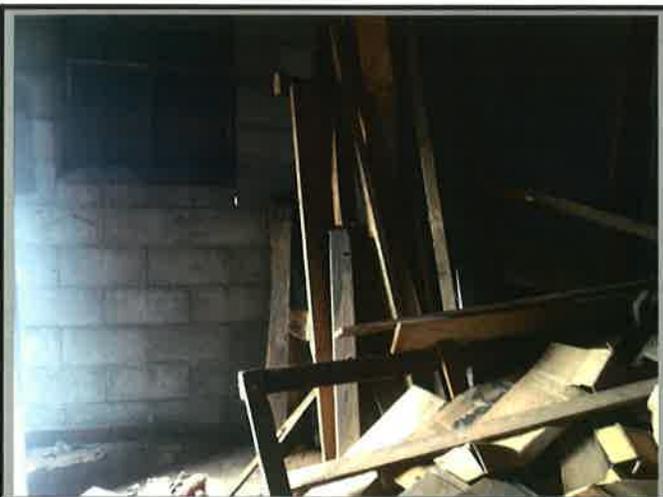
Photo 15

Concrete block mortar
