CMM Environmental

7/28/25

Re: **Asbestos Sampling 210 W Jefferson.**

On July 14 and 15, 2025, CMM Environmental conducted limited asbestos sampling at the above referenced location. During the inspection it was noted that the building may contain mercury switches, light ballasts and other hazardous materials that should be addressed prior to demolition.

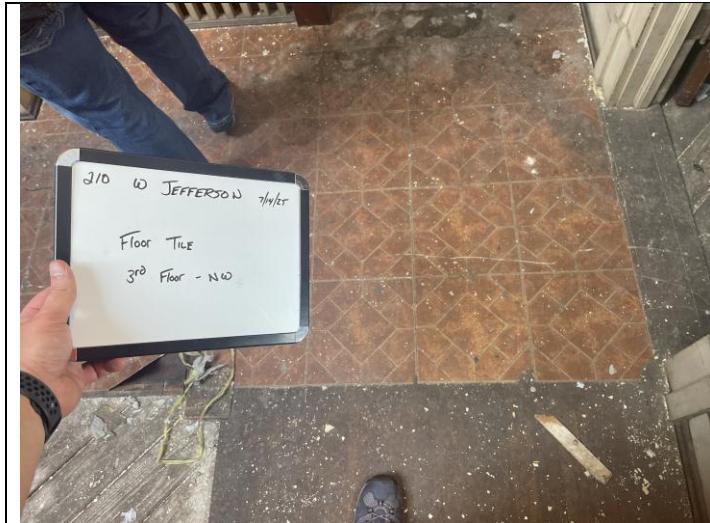
Date: 7/14/25
Location: 3rd Floor NW
Description: Floor Tile

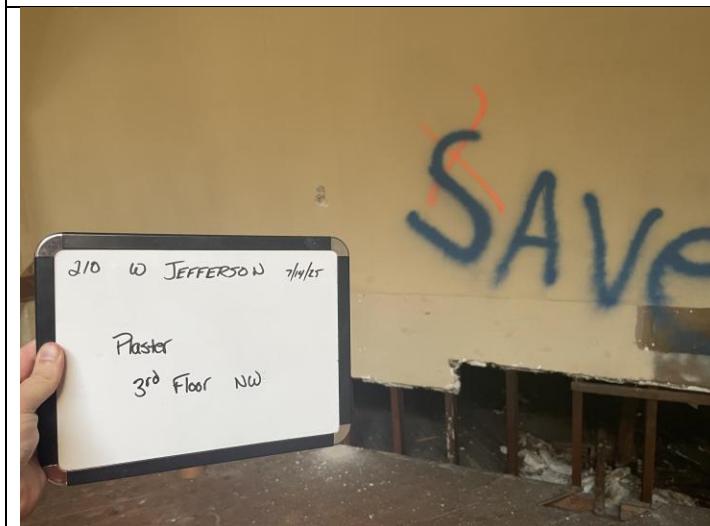
Date: 7/14/25
Location: 3rd Floor NW
Description: Plaster

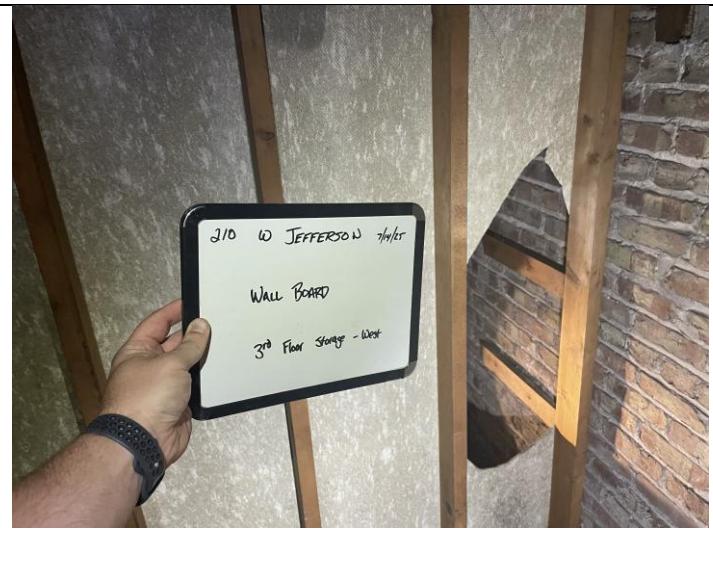
| Material Description | Material Location | Asbestos Type | Material Condition | Quantity |
|---|---|---|---|---|
| Wall Board | 3 rd Floor Storage – W | 15% Chrysotile | Damaged | TBD |

| | <p>Date: 7/14/25 Location: 3rd Floor Storage West Description: Wall Board</p> |

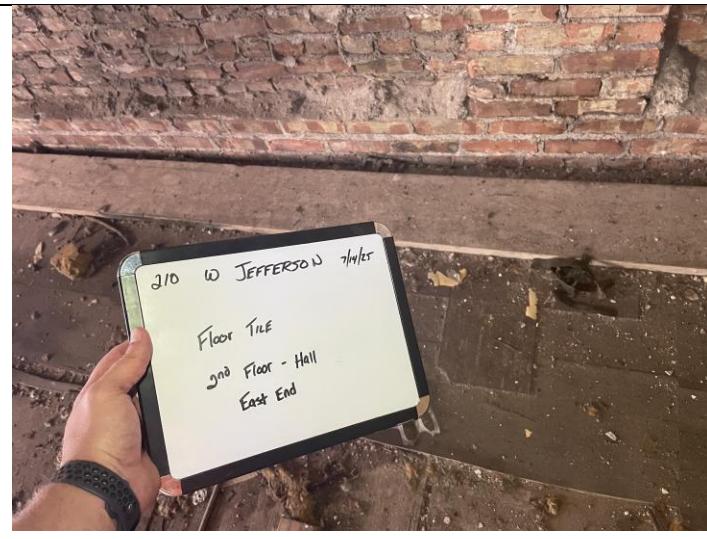
| Material Description | Material Location | Asbestos Type | Material Condition | Quantity |
|---|---|---|---|---|
| Floor Tile | 2 nd Floor Hall – East End | 5% Chrysotile | Severely Damaged | TBD |

| | <p>Date: 7/14/25 Location: 2nd Floor Hall East End Description: Floor Tile</p> |

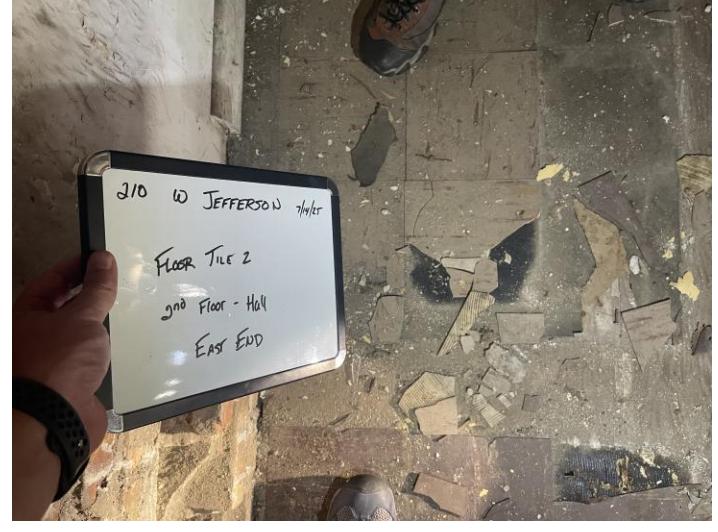
| Floor Tile 2 | 2 nd Floor Hall – East End | 5% Chrysotile | Severely Damaged | TBD |

| | <p>Date: 7/14/25 Location: 2nd Floor Hall East End Description: Floor Tile 2</p> |

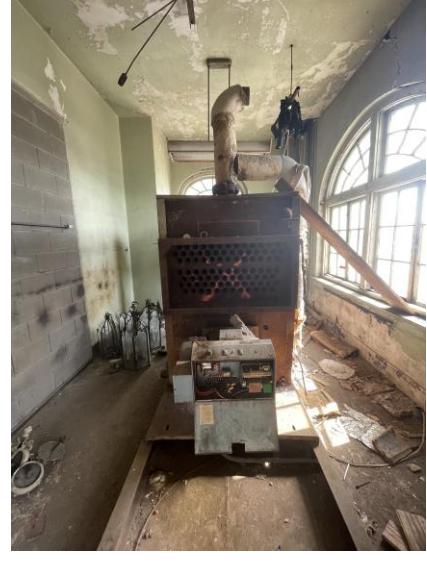
| Bolier | 1 st Floor Boiler NE | Assumed Asbestos | Damaged | 1 unit |

| | <p>Date: 7/14/25 Location: 1st Floor NE Corner Description: Boiler (assumed asbestos content)</p> |

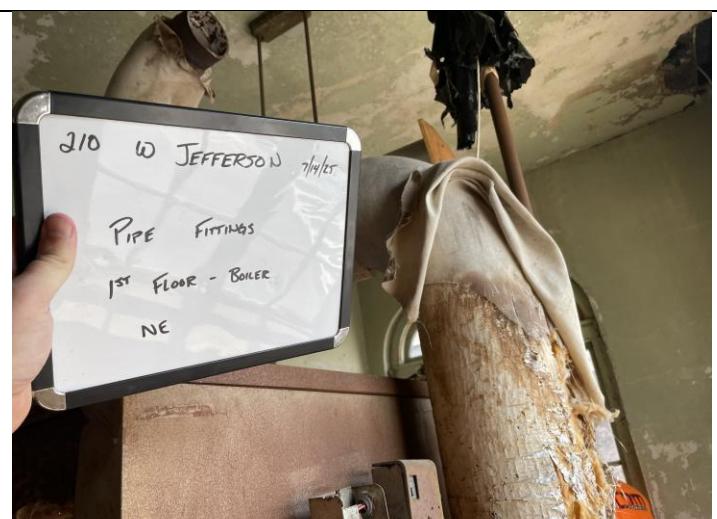
| A photograph showing a hand holding a clipboard with a whiteboard label. The label has handwritten text: "210 W JEFFERSON 7/14/15", "PIPE FITTINGS", "1st FLOOR - BOILER", and "NE". In the background, a large pipe fitting is visible, wrapped in insulation, with a cloth draped over it. The wall behind appears to be in a state of repair or renovation. | <p>Date: 7/14/25 Location: 1st Floor Boiler NE Description: Pipe Fitting</p> |

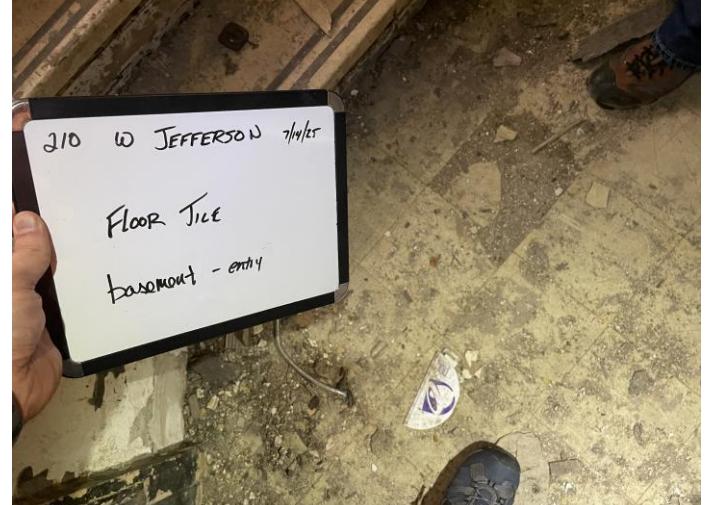
| Floor Tile | Basement Entry | 6% Chrysotile | Severely Damaged | TBD |

| | <p>Date: 7/14/25 Location: Basement Entry Description: Floor Tile</p> |

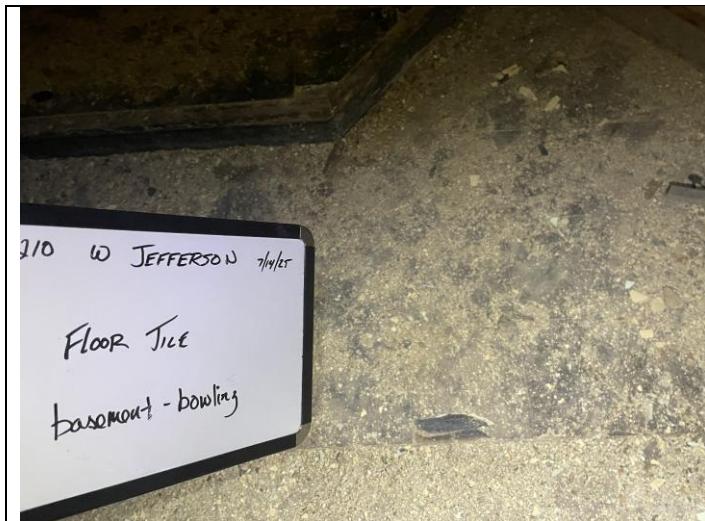
| Floor Tile | Basement Bowling | 2% Chrysotile | Severely Damaged | TBD |

Date: 7/14/25
Location: Basement Bowling
Description: Floor Tile

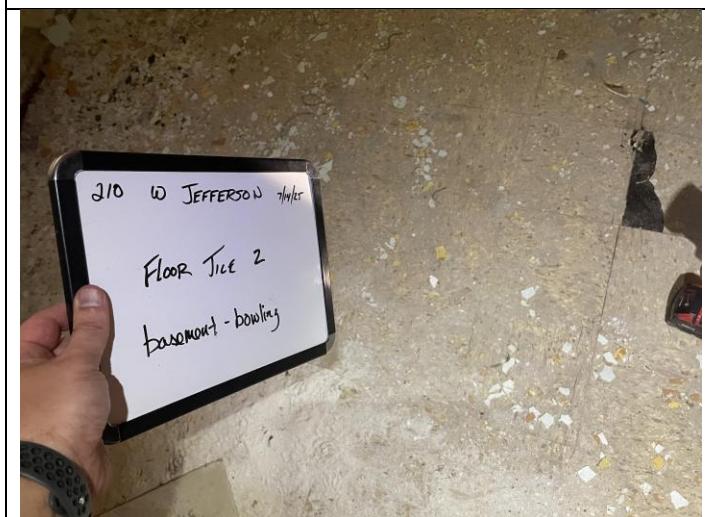
| Floor Tile 2 | Basement Bowling | 2% Chrysotile | Severely Damaged | TBD |

Date: 7/14/25
Location: Basement Bowling
Description: Floor Tile 2

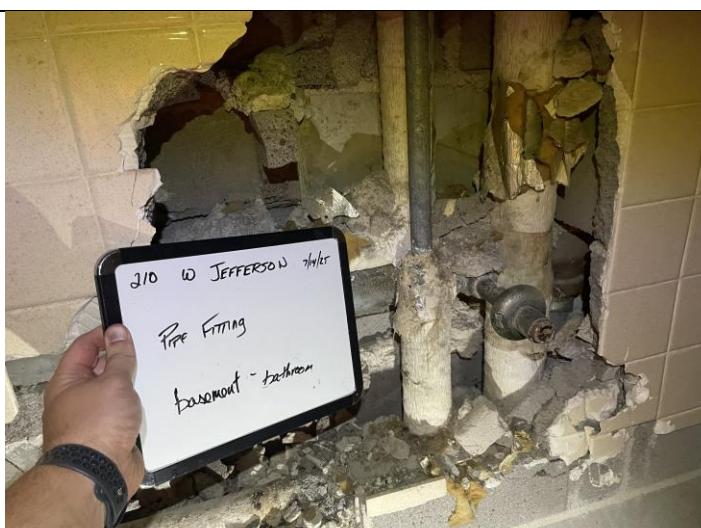
| Material Description | Material Location | Asbestos Type | Material Condition | Quantity |
|---|---|---|---|---|
| Pipe Fittings | Basement Bathroom | 10% Chrysotile | Severely Damaged | TBD |

| | <p>Date: 7/14/25 Location: Basement Bathroom Description: Pipe Fitting</p> |

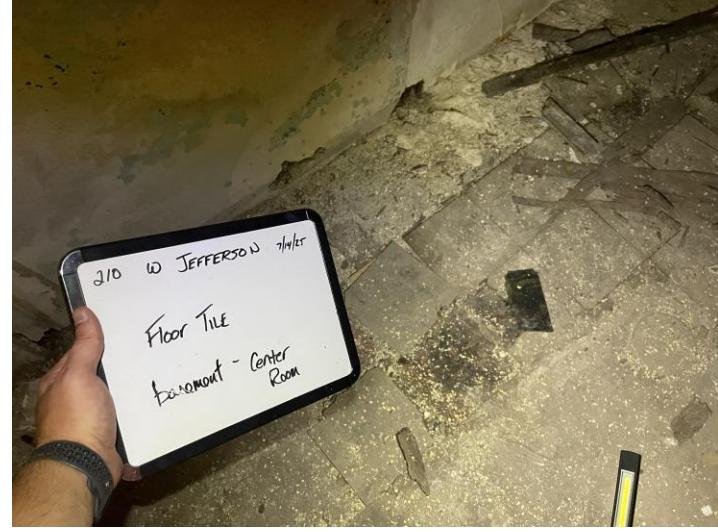
| Floor Tile | Basement Center Room | 5% Chrysotile | Severely Damaged | TBD |

| | <p>Date: 7/14/25 Location: Basement Center Room Description: Floor Tile</p> |

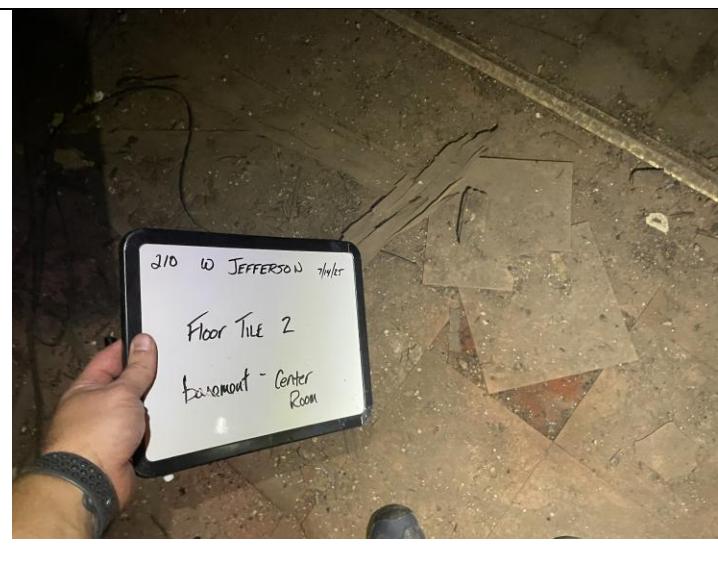
| | <p>Date: 7/14/25 Location: Basement Center Room Description: Floor Tile 2</p> |

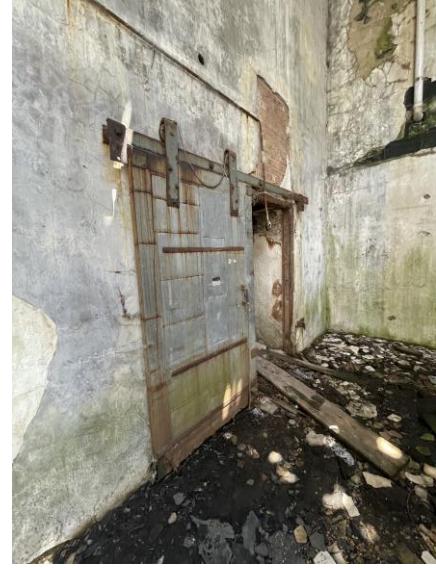
| | <p>Date: 7/14/25 Location: Basement Description: Fire Door (assumed asbestos content)</p> |

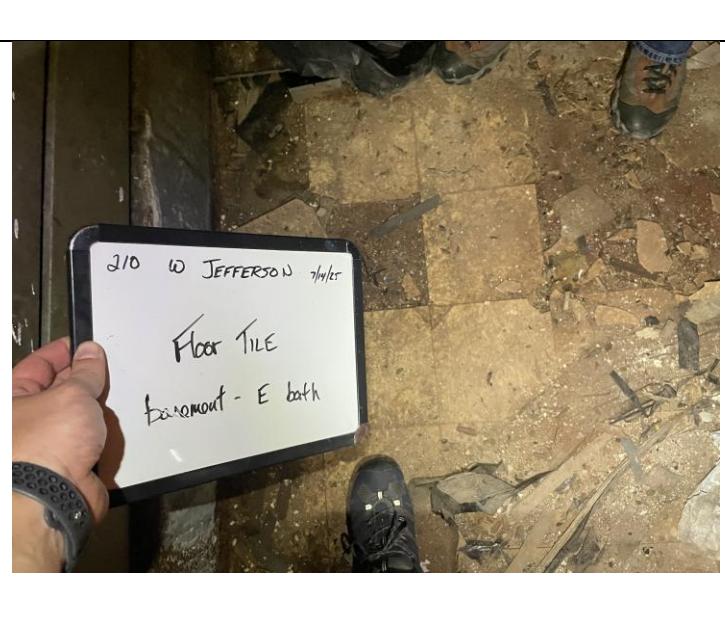
| Floor Tile | Basement E Bath | 4% Chrysotile | Severely Damaged | TBD |

| A photograph showing a person's hand holding a whiteboard in a basement. The whiteboard has handwritten text: "210 W JEFFERSON 7/14/25", "Floor Tile", and "basement - E bath". The background shows a floor with broken tiles and debris. | <p>Date: 7/14/25 Location: Basement E Bathroom Description: Floor Tile</p> |
