Auto-Oriented Commercial Node at New Street - Kishwaukee South of 15th Avenue

Auto-Oriented Commercial Node at Existing Street - Kishwaukee North of 15th Avenue

Auto-Oriented Commercial Node -
Broadway

Pedestrian-Oriented Commercial Node - Broadway

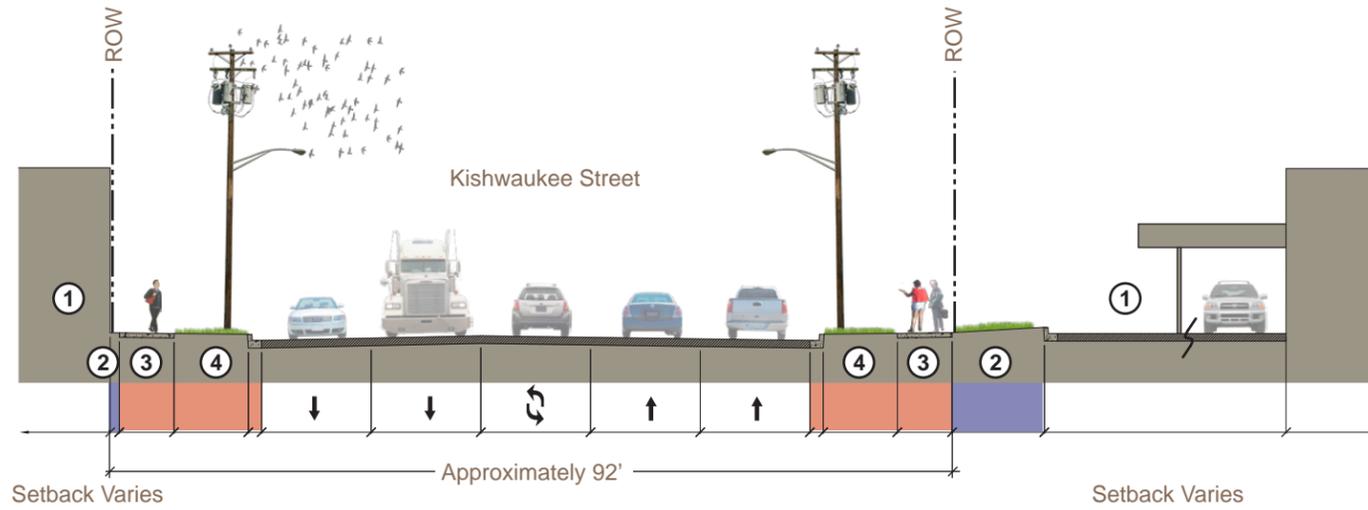
Existing Conditions

- ① Auto-oriented commercial
- ② Inadequate buffer
- ③ Degraded existing sidewalk
- ④ Underutilized parkway

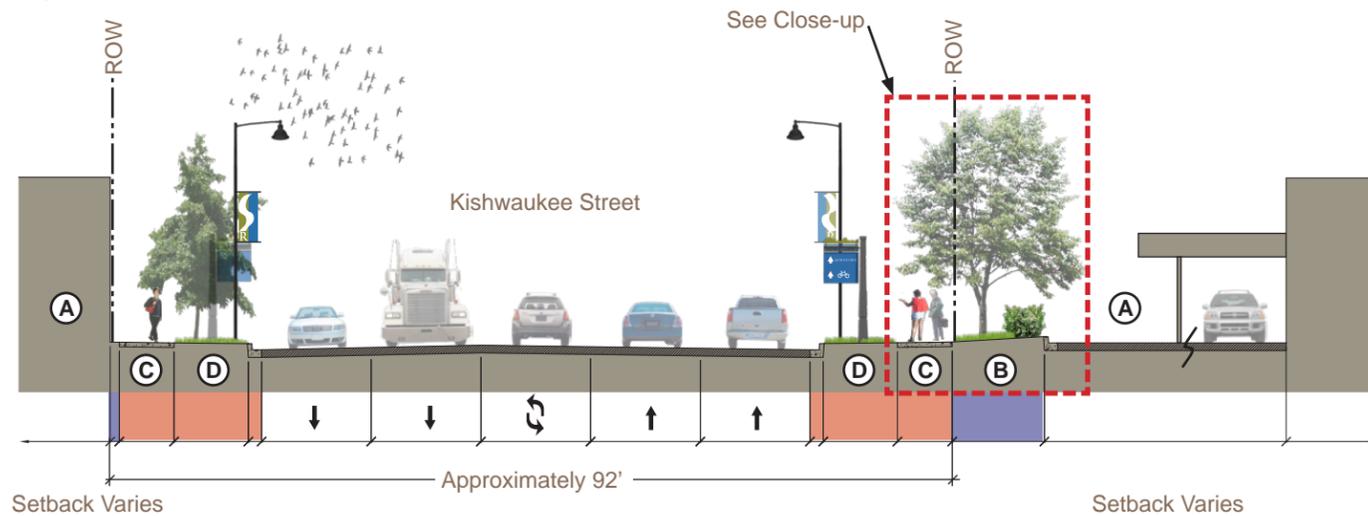
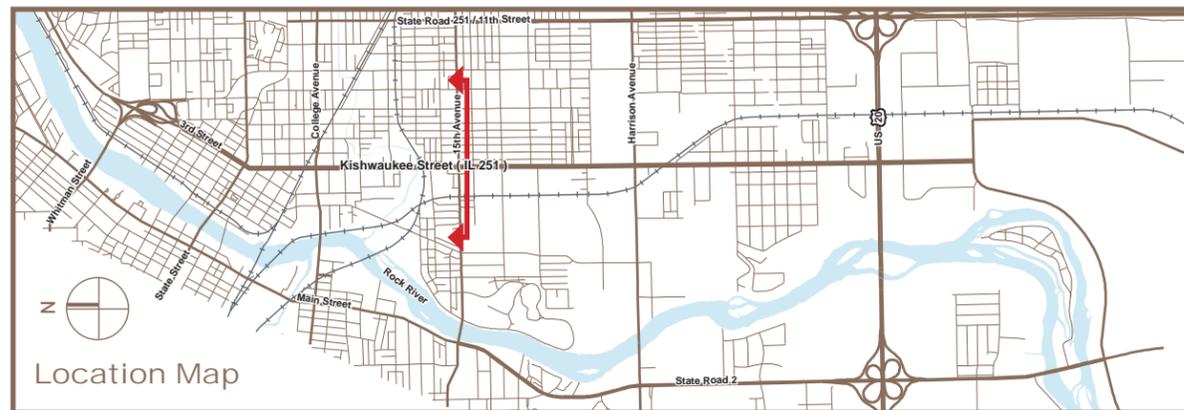
Figure 8

- Ⓐ Auto-oriented commercial
- Ⓑ Landscape buffer
- Ⓒ Updated sidewalk
- Ⓓ Updated parkway

- Public Improvement Area
- Private Improvement Area

*Corridor alignment to be updated by IDOT

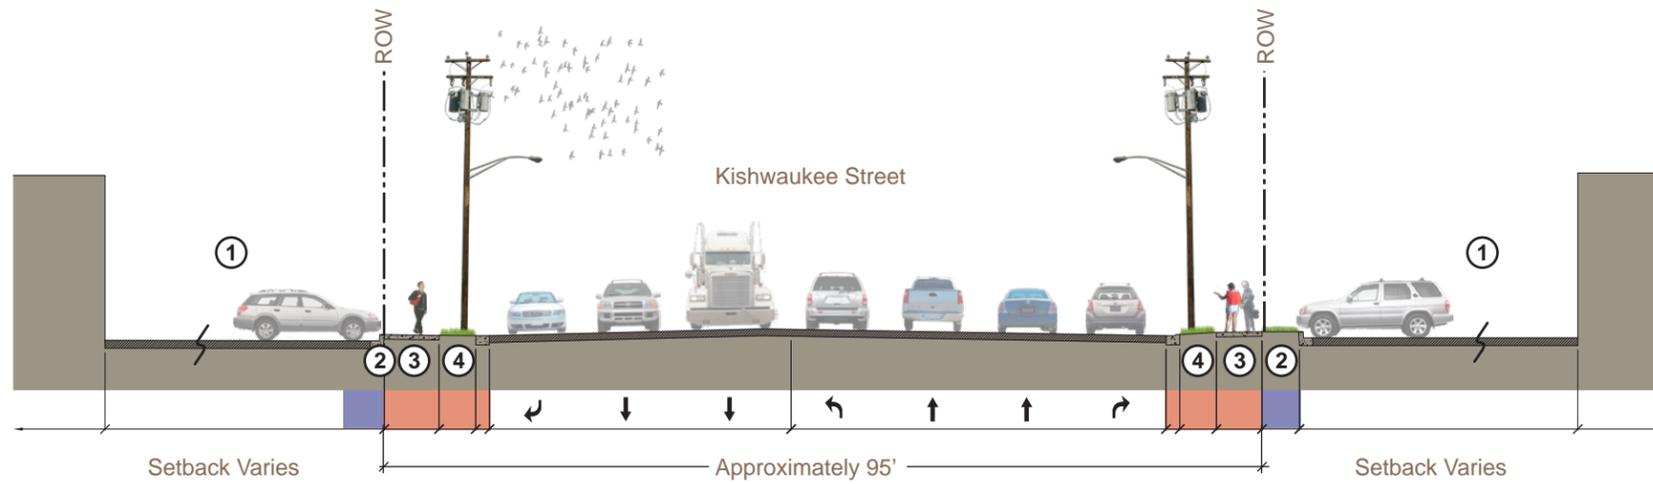
Existing Conditions

- ① Auto-oriented commercial
- ② Inadequate buffer
- ③ Degraded existing sidewalk
- ④ Underutilized parkway

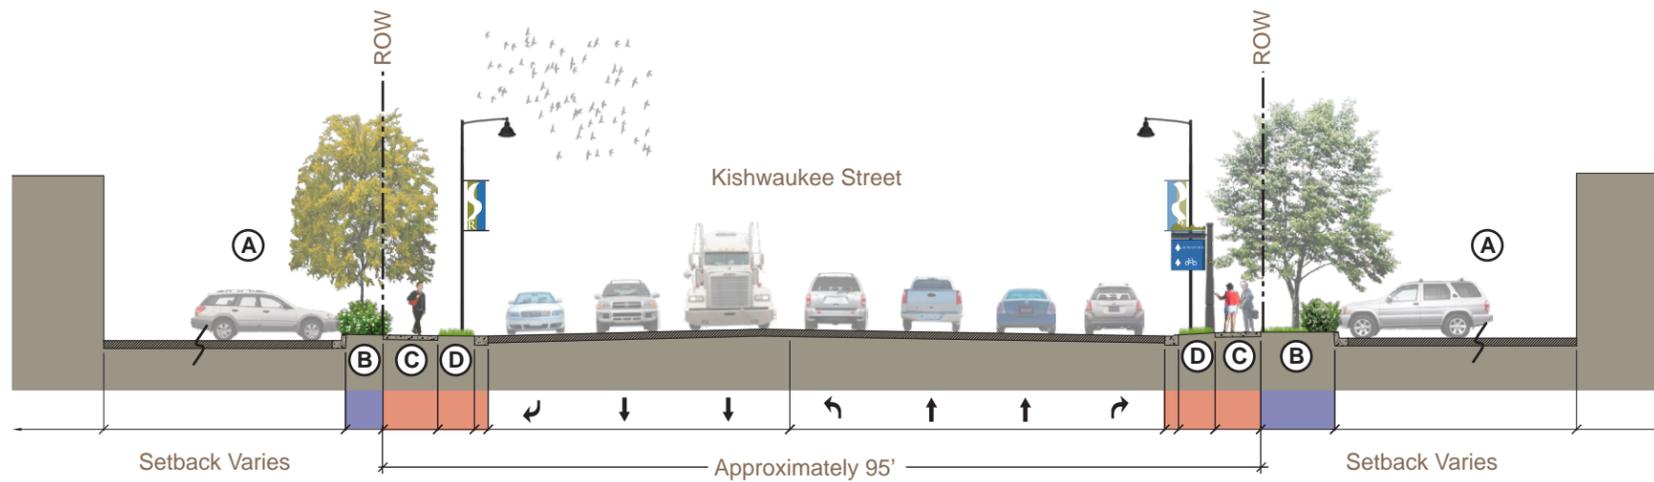
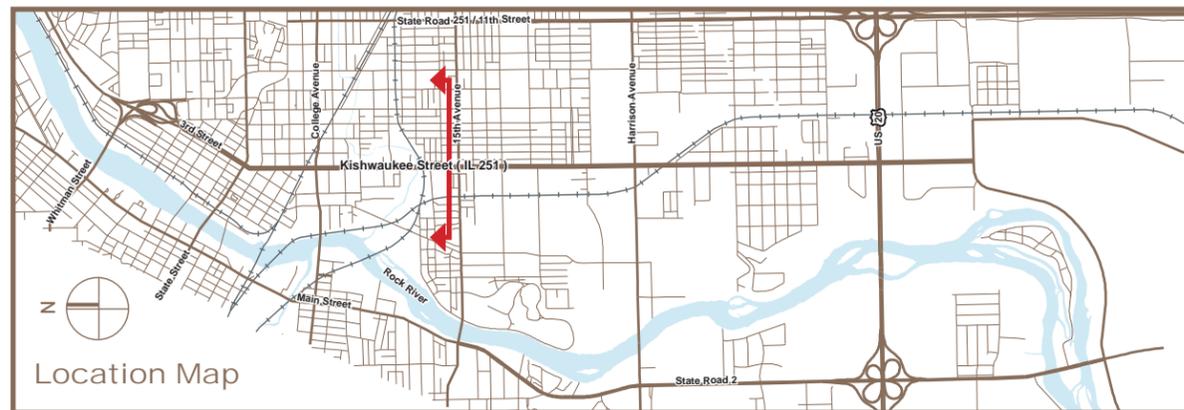
Figure 9

- Ⓐ Auto-oriented commercial
- Ⓑ Landscape buffer
- Ⓒ Updated sidewalk
- Ⓓ Updated parkway

- Public Improvement Area
- Private Improvement Area

*Corridor alignment to remain as existing

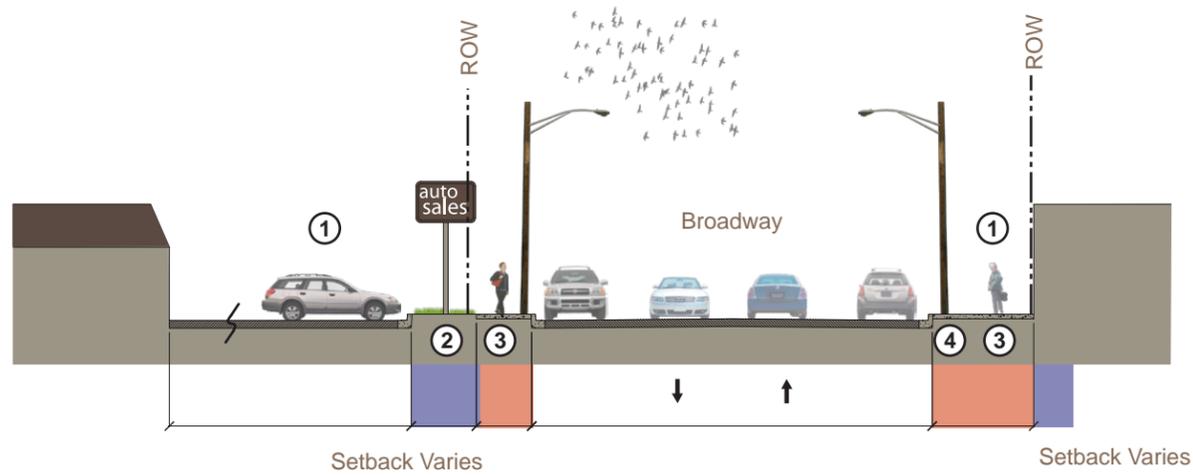
Existing Conditions

- ① Auto-oriented commercial
- ② Inadequate buffer
- ③ Degraded existing sidewalk
- ④ Underutilized parkway

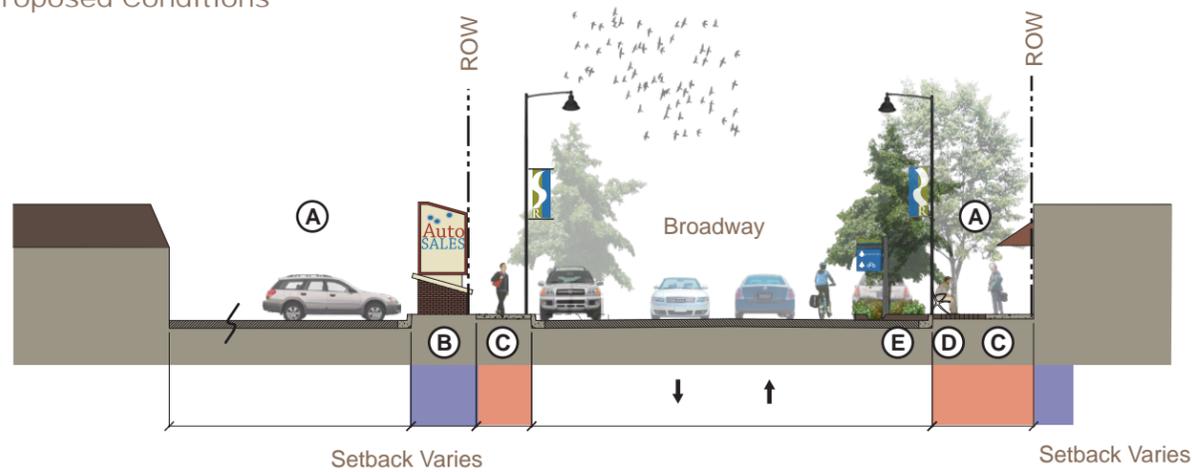
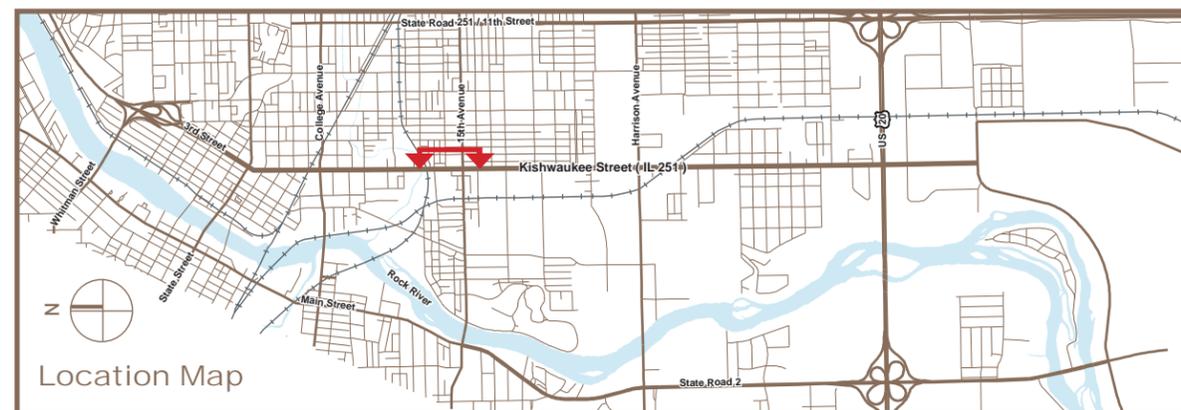
Figure 10

- Ⓐ Auto-oriented commercial
- Ⓑ Landscape buffer with monument signage
- Ⓒ Updated sidewalk
- Ⓓ Updated parkway
- Ⓔ Stormwater intercepting curb extension

- Public Improvement Area
- Private Improvement Area

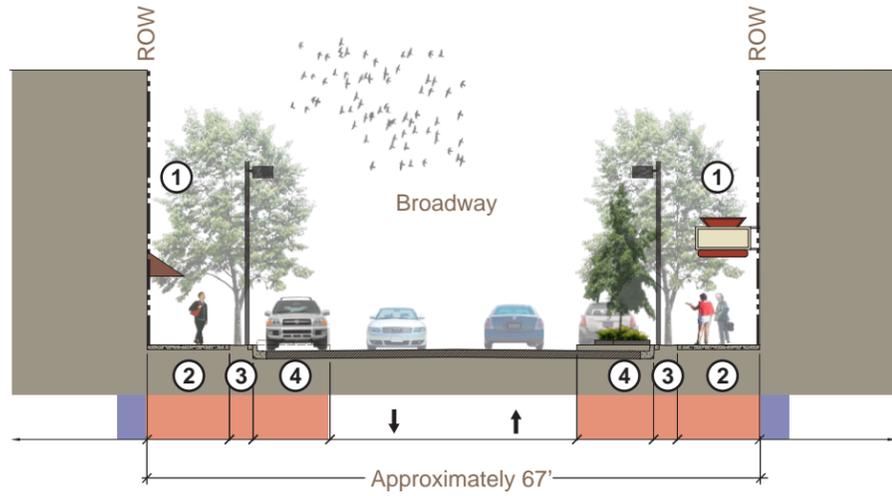
Existing Conditions

- ① Pedestrian-oriented commercial
- ② Degraded existing sidewalk
- ③ Underutilized parkway
- ④ Underutilized curb extensions

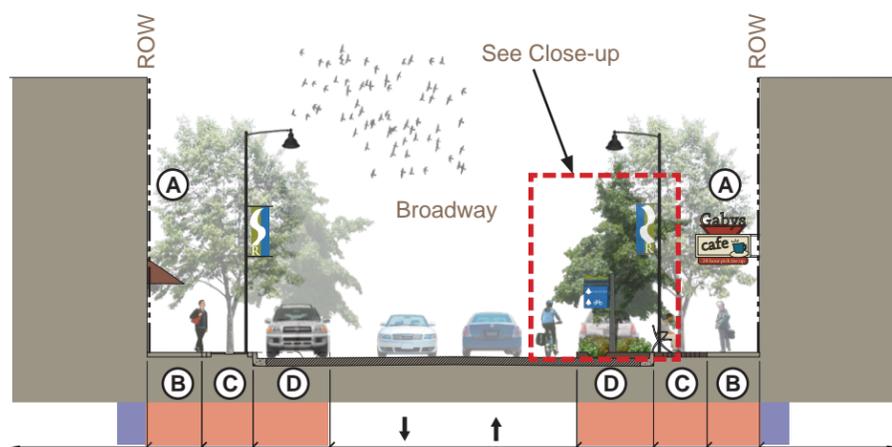
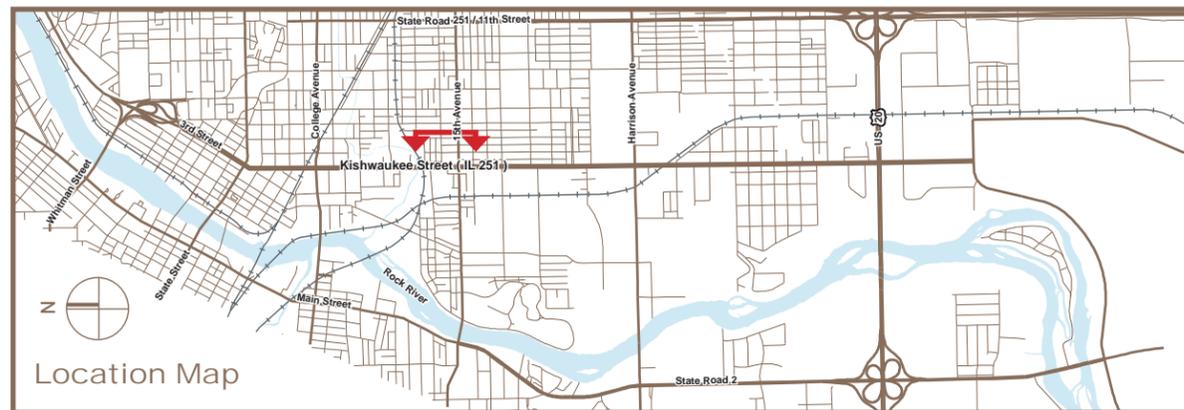
Figure 11

- Ⓐ Pedestrian-oriented commercial
- Ⓑ Updated sidewalk
- Ⓒ Updated parkway
- Ⓓ Stormwater intercepting curb extension

- Public Improvement Area
- Private Improvement Area

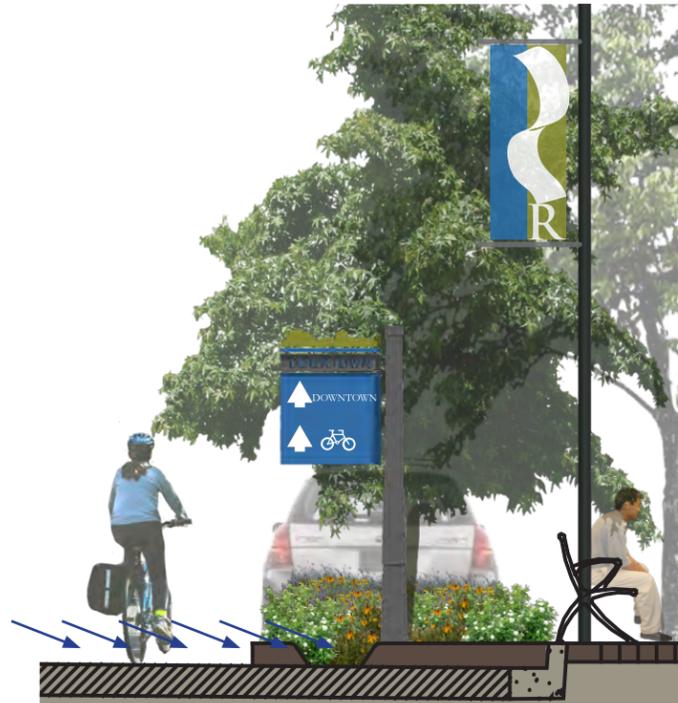
D Water Intercepting Curb-Extension

Stormwater Management & Beautification

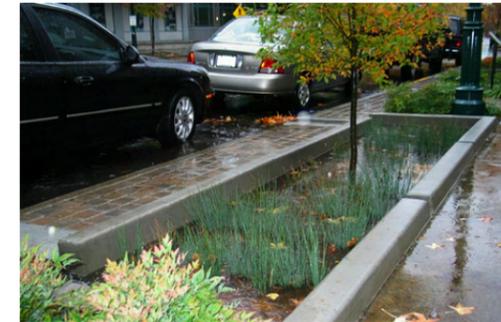
Stormwater Interception Planter

Images from City of Portland Oregon - 12th Ave. Green Street Project
