**ANNUAL REPORT
Calendar Year 2024
CITY OF ROCKFORD, ILLINOIS
MUNICIPAL SEPARATE STORM SEWER SYSTEM**

NPDES Permit No. ILS000001

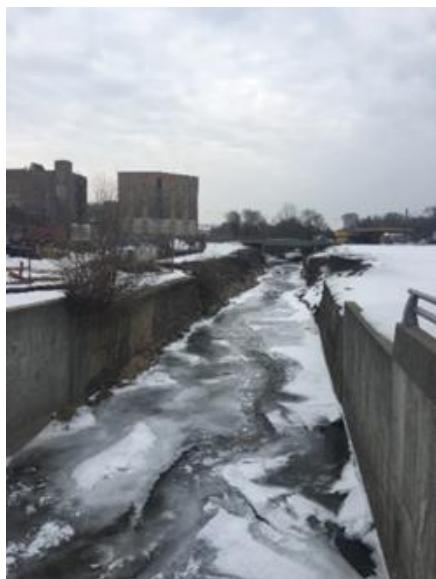
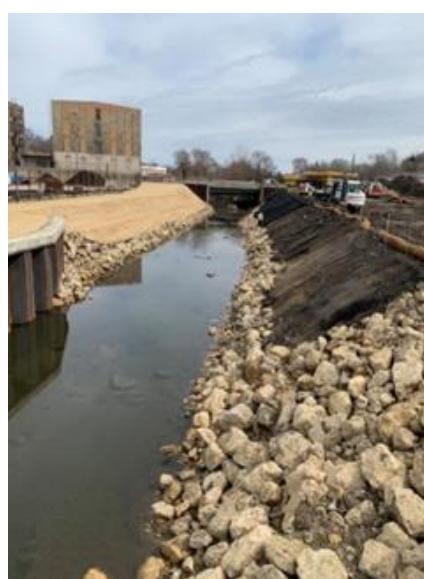
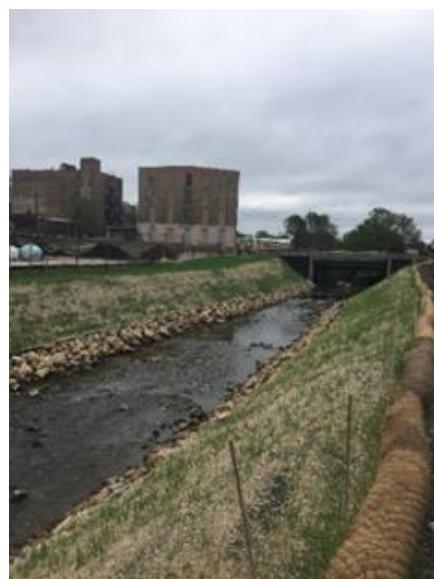
2019 Keith Creek Bank Stabilization

In 2019, the City stabilized approximately 1,600 feet of eroding streambank along Keith Creek. This project included the removal of two bridges and because of space issues a combination of pilings, rip rap and vegetative stabilization with geogrids. City staff have continued to monitor this area to ensure vegetation is established and no washouts have occurred. Additional studies are in progress for future projects along the Keith Creek corridor.

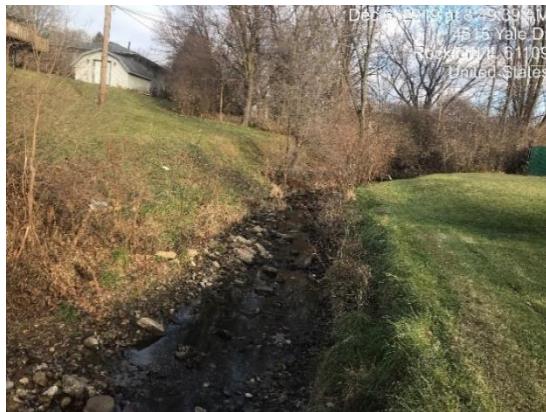
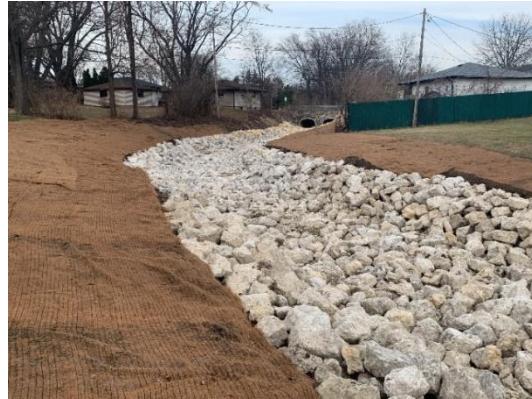
Buckbee Channel Bank Stabilization

In 2022, the City stabilized approximately 1,000 feet of the Buckbee Channel south of Yale Drive which included relocation of sanitary, phone and electrical lines.

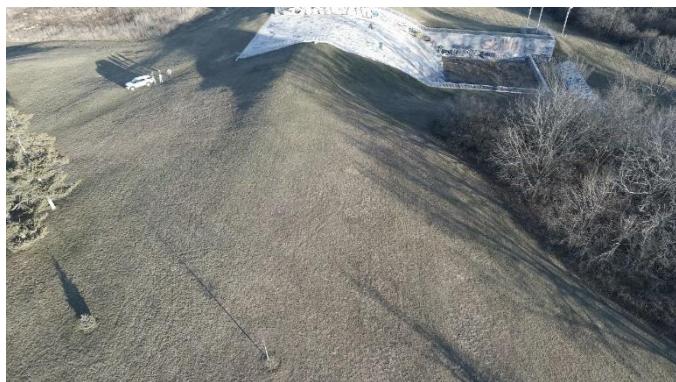
Alpine Dam Upgrades before Phase 2 Upgrades

In 2020, the City of Rockford Public Works, Engineering Division started Phase 1 of the Alpine Dam Rehabilitation Project. A new gate actuator was installed on the intake tower as well as a radar water level gage, a doppler radar moisture sensor, Phase 1 of this project also consisted of the removal of graffiti from the existing concrete spillway as well as from the access bridge and intake tower. Also, multiple repairs were made to the concrete joints in the overflow spillway and chute and the stilling basin was completely cleaned out. Electrical upgrades, CCTV cameras, and a software package to control and capture data from all of the new equipment. With the addition of this new equipment the Engineering Division can now monitor the dam and activate the flood gate remotely if needed. Phase 2 of this project was approved by IDNR in 2023 and the City was able to get a grant to partially fund the project. This project went out to bid in December of 2023 and was completed in 2024. Phase 2 improvements included: bolstering structural integrity of the existing spillway by installing one foot of concrete over the entire spillway floor and walls as well as the chute and stilling basin, modernization of the current stilling basin by reconstructing velocity dissipation structures, replacing the original collapsed clay drain pipe and construction of an auxiliary earthen spillway adjacent to the existing concrete spillway in order to meet modern engineering standards and allow the dam to maintain structural integrity by creating a secondary release point for flood waters.

- Trash racks were replaced at Alpine Dam in 2016. In 2018, the City entered into an Engineering Agreement with HNTB to provide plans to rehabilitate Alpine Dam which started in 2020. Phase 2 was completed in 2024.

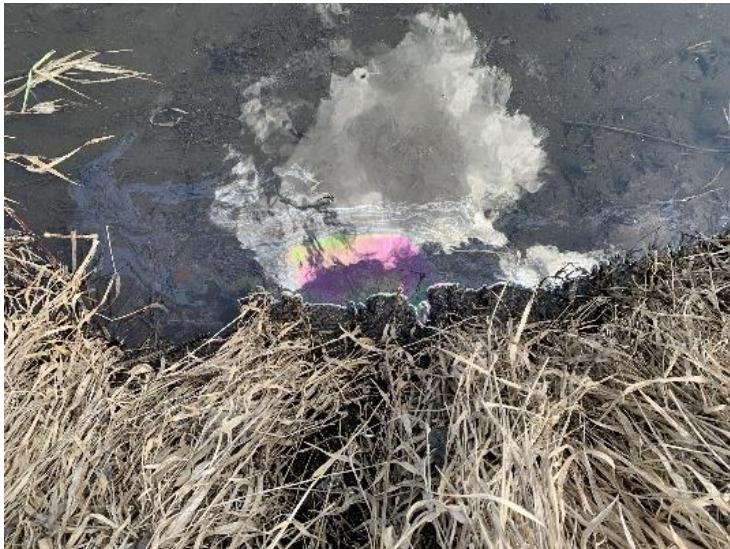
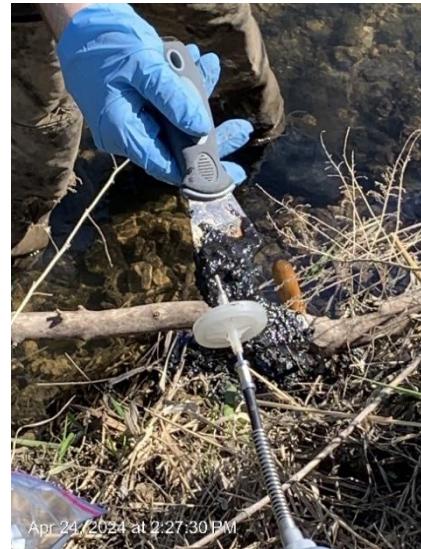
In April of 2024 our Stormwater Senior Engineering Technicians were performing biennial outfall inspections and noticed an oily sheen along the western bank of the north branch of Kent Creek. After further investigation, our Stormwater team found multiple locations where oil laden groundwater was being discharged into Kent Creek. We also noticed a strong crude oil odor coming from the bank of the creek as well. We contacted Fehr Graham, a local environmental and engineering consultant, to take samples from the discharge locations. Their initial PID reading at the point of discharge showed between 5 – 15 ppm for VOCs. Fehr Graham collected multiple soil samples from the creek bank and sent them off to a lab to be tested for VOCs, Semi VOCs, Total Petroleum Hydrocarbons, and Extended Range Organics. These tests were needed to identify the type of oil present in the discharge. Based on historical data from the area, our best guess for the source of the oil was either a spill from a rail car or a discharge from residual oil deposits on the former ComED/Nicor MGP site that was located along Avon St. Once we had a chance to analyze the results from Fehr Graham, we noticed a very high reading for Total Petroleum Hydrocarbons at the southernmost sample site adjacent to the location where the initial discharge was first noticed. The TPH at that sample site was 4360 ppm which was well above the threshold of 2000 ppm for subsurface soils. The samples also indicated the presence of Benzo(a)pyrene which is a product of fossil fuel combustion which led us to believe that the oil was being discharged from the former ComED/Nicor MGP site. After analyzing the results, we contacted the IEPA who sent a team out to meet with us at Kent Creek. After investigating the site, the IEPA issued Notices of Violation to The City of Rockford, CN Railroad, and ComED/Nicor. The City of Rockford has responded to our Notice of Violation by explaining that although we own the land along the bank of the creek where the discharge is occurring, it is our belief that the oil discharge has migrated through our property and the CN Railroad property originating from the former ComED/Nicor MGP site. Our Stormwater Team along with our Brownfields Redevelopment Specialist has been maintaining an observation log of the site as well as installing multiple oil absorbent booms in an attempt to mitigate any further discharge into Kent Creek. The City of Rockford is currently waiting on the IEPA to follow up after their meetings with all parties involved to discuss the Notice of Violation.

Observed oily discharge entering Kent Creek

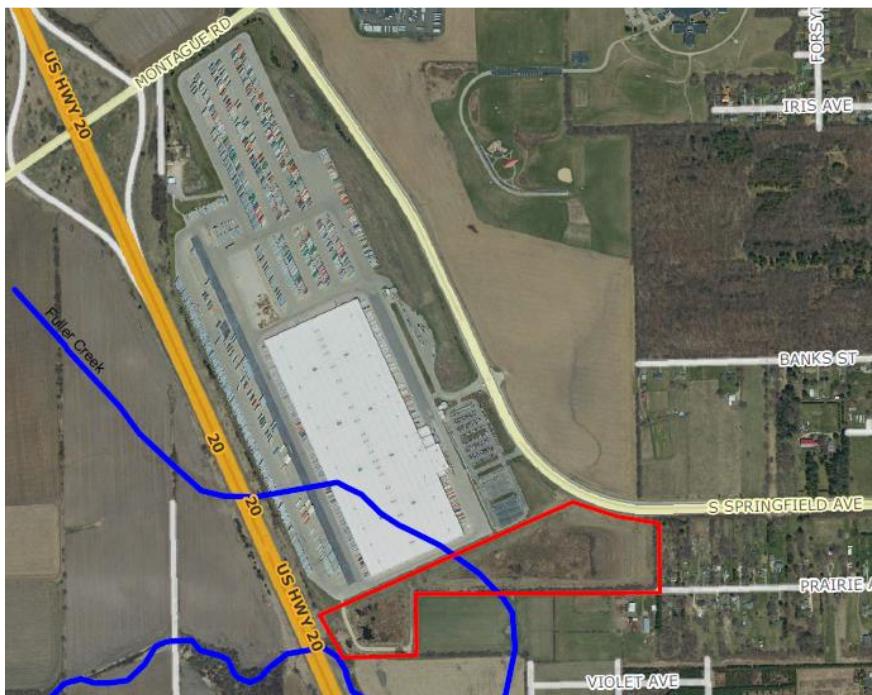
Location: SE Springfield Ave & Montague Rd.

Year	Maintenance
2015	Routine Mowing
2016	Routine Mowing
2017	Routine Mowing
2018	Routine Mowing
2019	Routine Mowing
2020	Routine Mowing
2021	Routine Mowing
2022	Routine Mowing
2023	Routine Mowing, HR Green completing analysis for retrofitting
2024	Routine Mowing

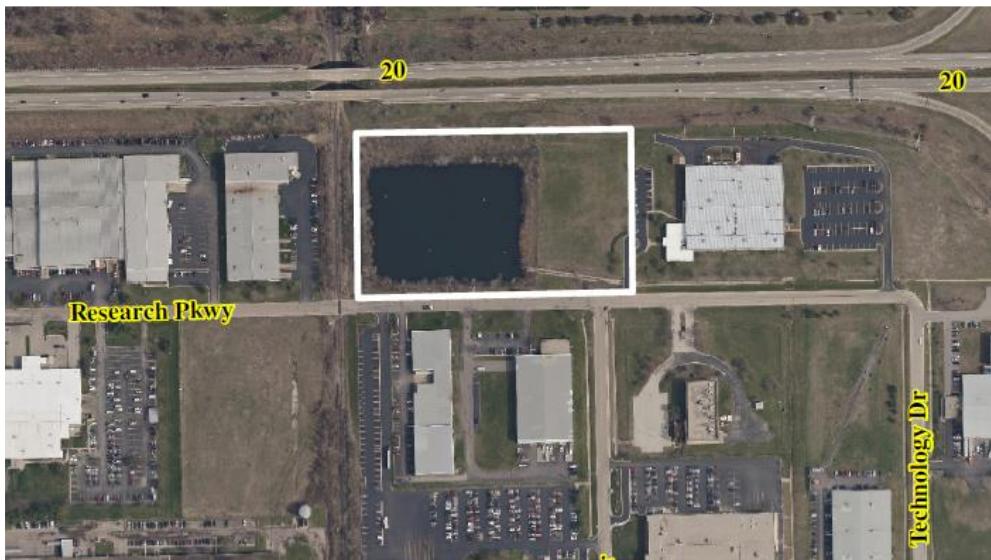
Location: 1052 Research Parkway

Year	Maintenance
2015	Routine Mowing
2016	Routine Mowing
2017	Routine Mowing
2018	Routine Mowing
2019	Routine Mowing
2020	Routine Mowing
2021	Routine Mowing
2022	Routine Mowing
2023	Routine Mowing, HR Green completing analysis for retrofitting
2014	Routine Mowing

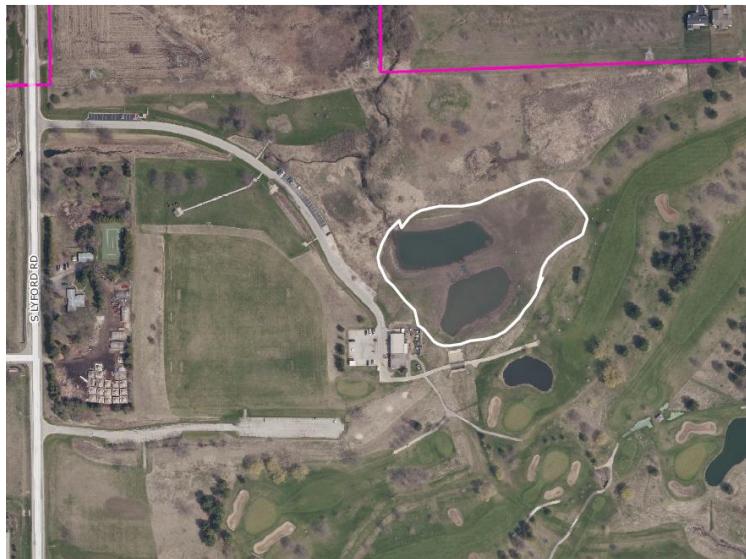
Location: 888 South Lyford Road

Year	Maintenance
2015	Routine Mowing
2016	Routine Mowing, debris removal
2017	Woody debris removal, pipe repair, erosion repair and stabilization
2018	Routine Mowing
2019	No required Maintenance
2020	Routine Mowing
2021	Facility was closed by Rockford Park District. Minimal maintenance taking place
2022	Expansion of basin has been approved to accommodate new casino to west. Construction being done by casino in 2023.
2023	Basin expanded to address added casino runoff, HR Green completing analysis for retrofitting
2024	While the basin structure is still be responsibility of the City of Rockford the basin property, which includes the basin and golf course, was purchased by Severson Dells where they intend to convert it to a natural area.

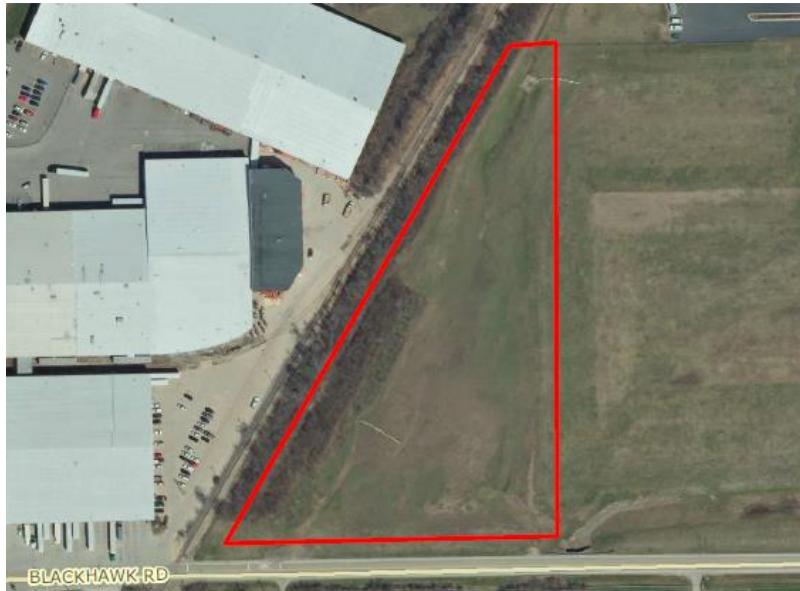
Location: 1650 Blackhawk Road

Year	Maintenance
2015	Dry wells installed for better drainage, Routine Mowing
2016	Routine Mowing
2017	Routine Mowing
2018	Routine Mowing
2019	Routine Mowing
2020	Routine Mowing
2021	Routine mowing and repair of gully where it enters SE drainageway.
2022	Routine Mowing
2023	Routine Mowing, HR Green completing analysis for retrofitting
2024	Routine Mowing

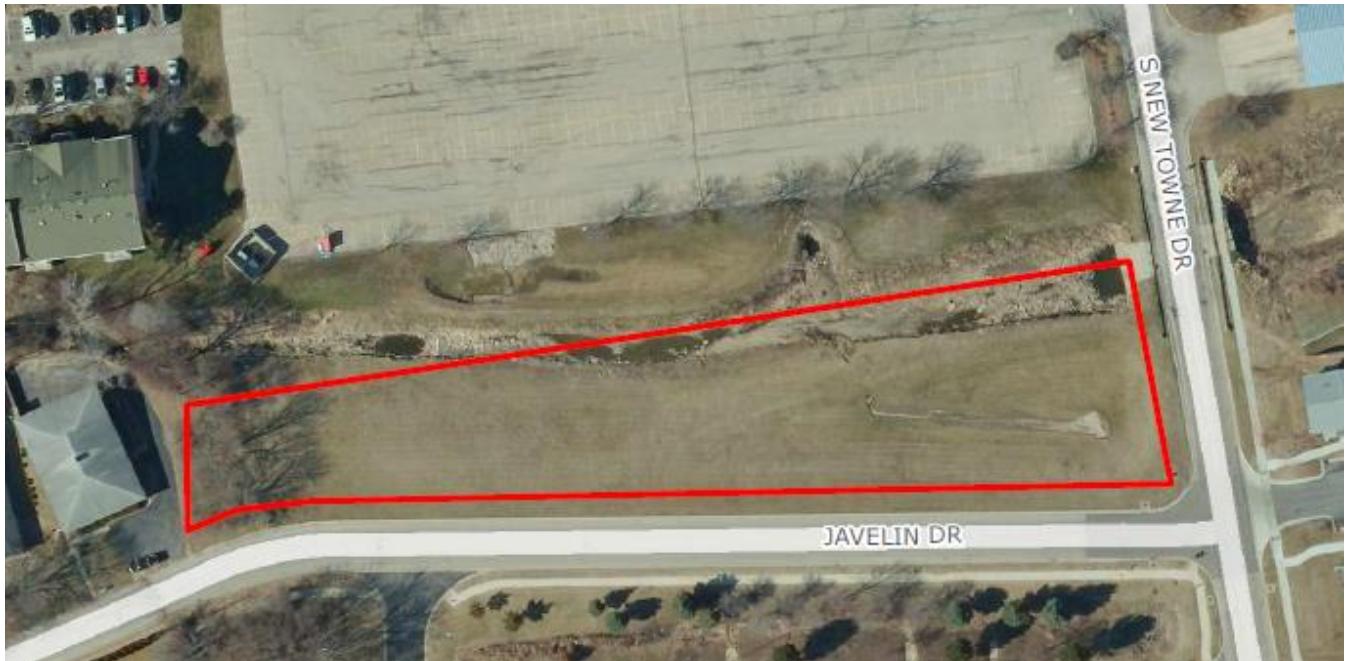
Location: NW New Towne and Javelin Drives

Year	Maintenance items
2014	Removed 37.66 tons of sediment from concrete channel and reseeded and routine mowing
2015	Routine Mowing
2016	Removal of 1 ton of sediment and added riprap to prevent erosion. Routine Mowing
2017	Routine Mowing
2018	Routine Mowing
2019	Routine Mowing
2020	Routine Mowing
2021	Routine Mowing
2022	Routine Mowing
2023	Routine Mowing, HR Green completing analysis for retrofitting
2024	Routine Mowing

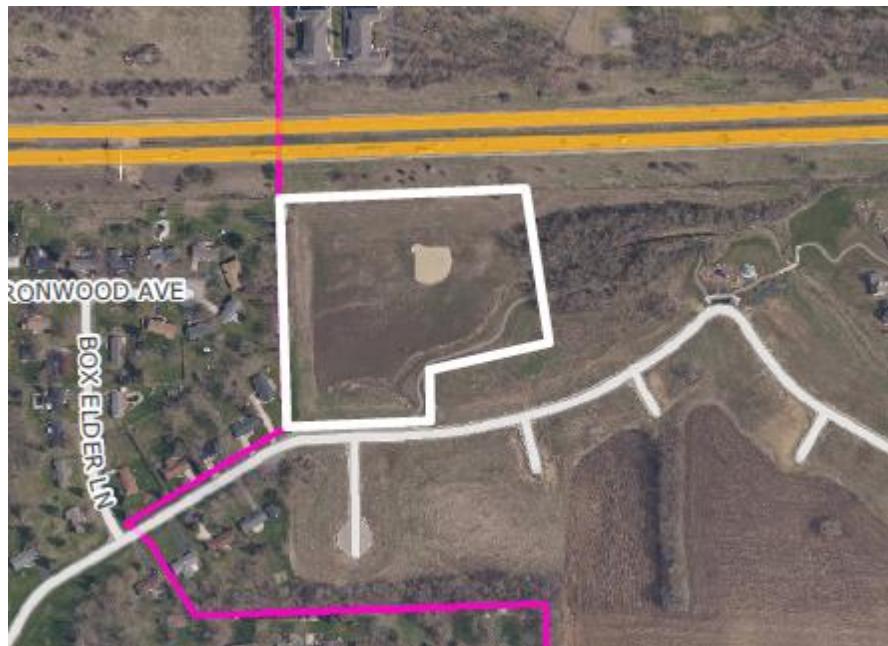
Location: Scarlet Oak Drive and Bypass 20

Year	Maintenance items
2015	Routine Mowing & tree removal
2016	Routine Mowing & repairs to berm.
2017	Routine Mowing
2018	Routine Mowing
2019	Routine removal & tree removal
2020	Routine Mowing
2021	Minimal maintenance by the Rockford Park District though still operational.
2022	Minimal maintenance by the Rockford Park District though still operational.
2023	Minimal maintenance by the Rockford Park District though still operational.
2024	Basin Mowed

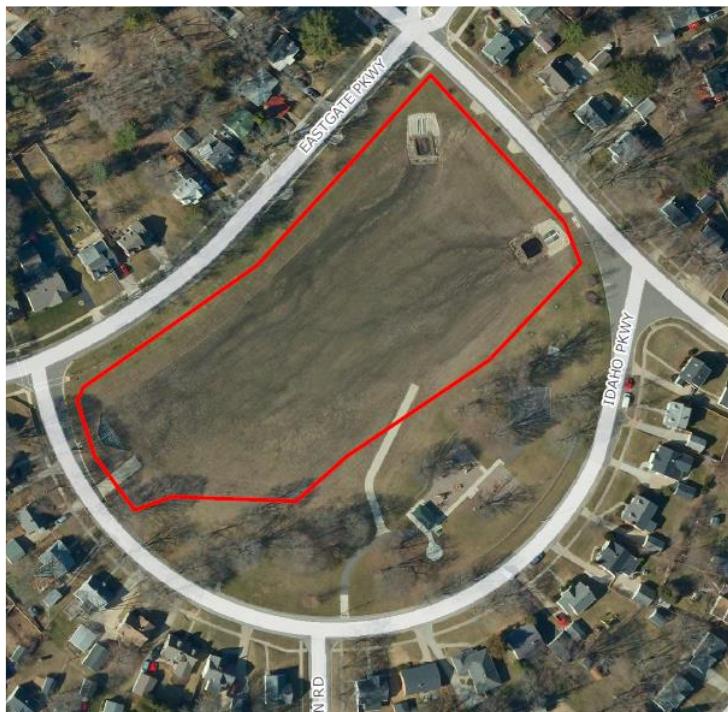
Location: Executive 1924 East Gate Parkway

Year	Maintenance items
2016	Regional basin was built.
2017	Routine Mowing
2018	Routine Mowing
2019	Routine Mowing & Removal of Sediment from Baskets
2020	Routine Mowing
2021	Routine mowing, removal of sediment from trash racks and repair of gullies
2022	Routine Mowing
2023	Routine Mowing
2024	Routine Mowing

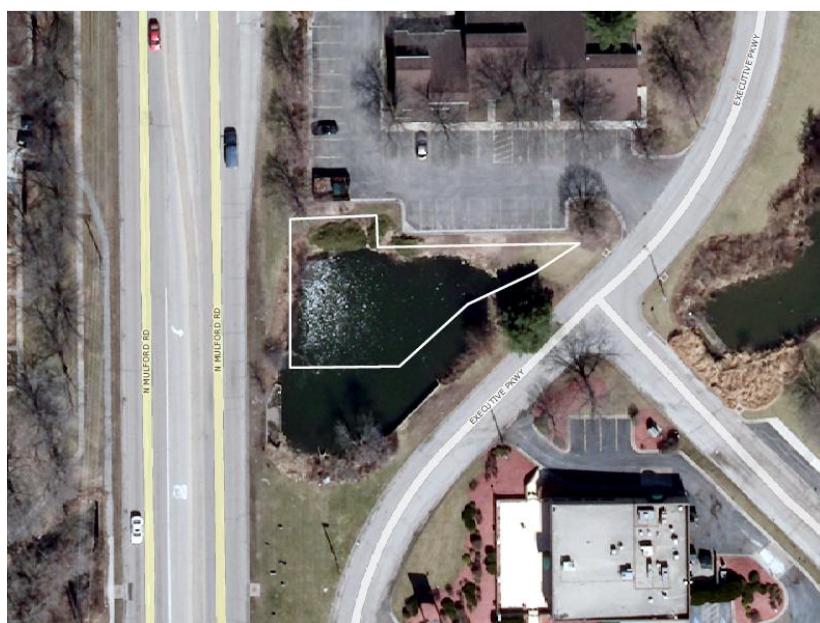
Location: Executive Parkway east of Mulford Road

Year	Maintenance items
2015	Inspection indicated no immediate maintenance is needed.
2016	Inspection indicated no immediate maintenance is needed.
2017	Association contacted to complete maintenance
2018	Routine Mowing
2019	Association contacted to complete maintenance
2020	Routine Mowing
2021	Association contacted to repair unseated pipe though basin is still operational
2022	Minimal Maintenance
2023	Minimal Maintenance
2024	Minimal Maintenance

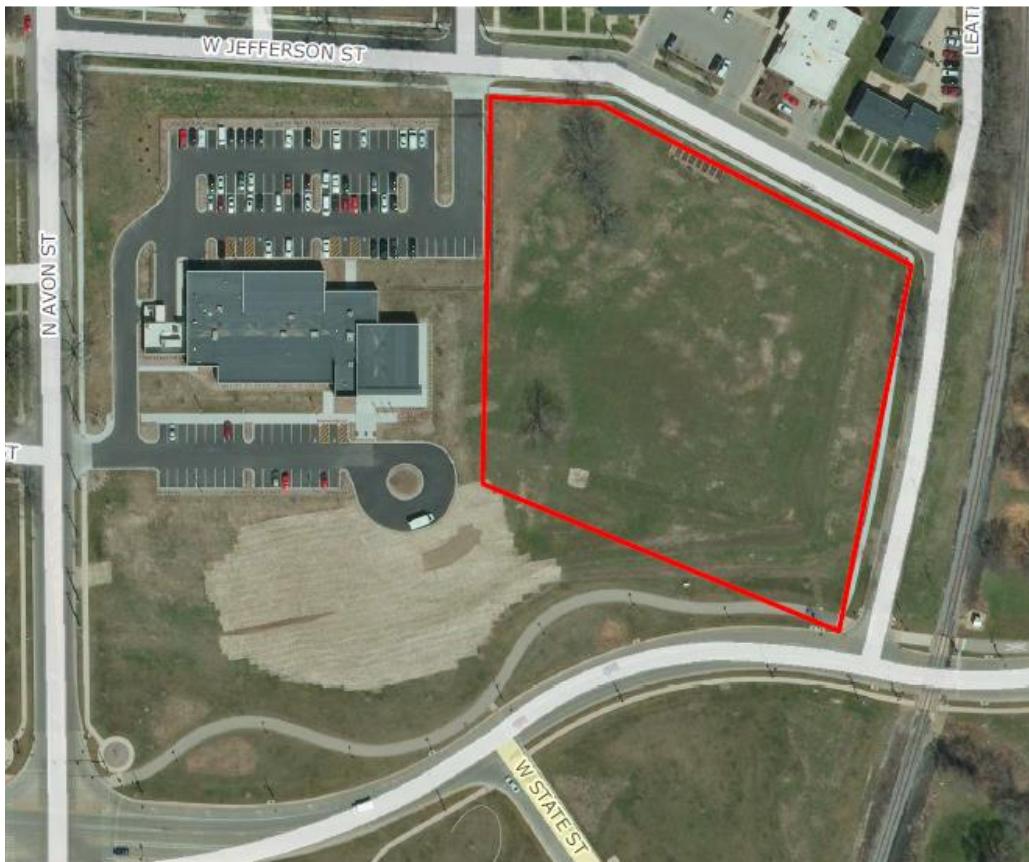
Location: 227 Avon St.

Year	Maintenance items
2016	Basin Built in 2016
2017	Routine Mowing
2018	Routine Mowing
2019	Routine Mowing
2020	Routine Mowing
2021	Routine Mowing
2022	Routine Mowing
2023	Routine Mowing HR Green Completing analysis for possible retrofitting
2024	Repaired undercutting channel, routine mowing

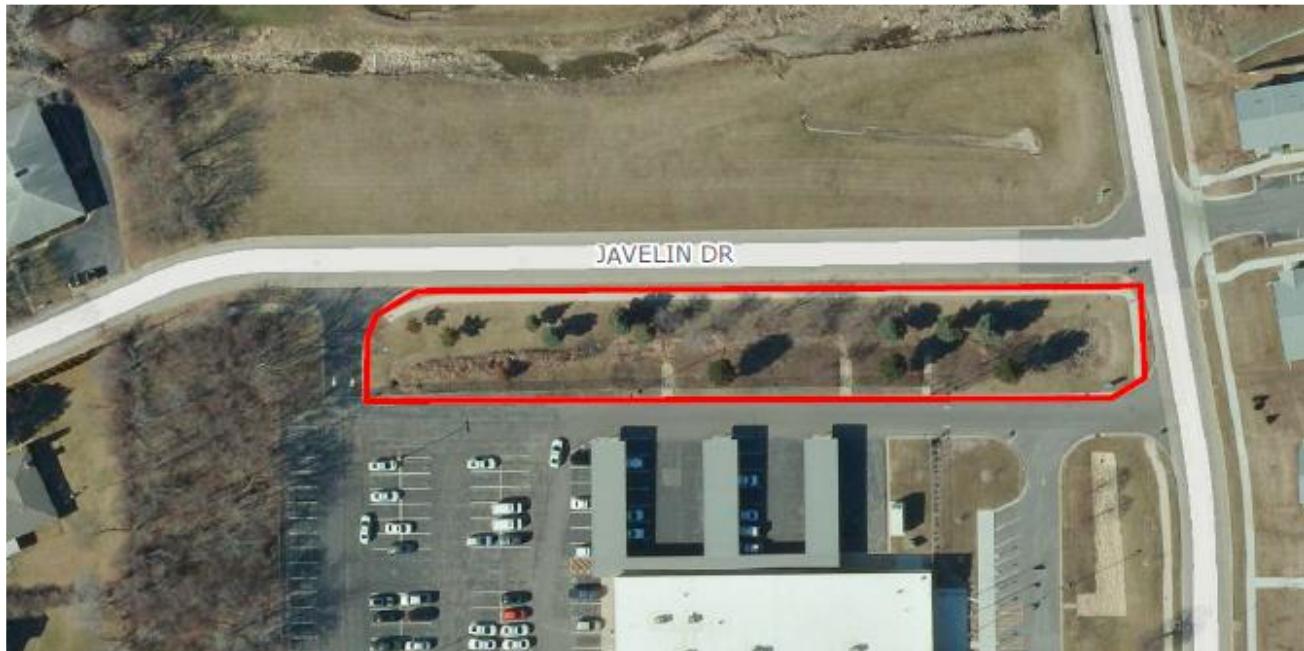
Location: 557 S. New Towne Dr.

Year	Maintenance items
2015	Routine Mowing
2016	Routine Mowing
2017	Trees cleared from basin & Routine Mowing
2018	Routine Mowing
2019	Routine Mowing
2020	Routine Mowing
2021	Routine Mowing
2022	Routine Mowing
2023	Routine Mowing
2024	Routine Mowing

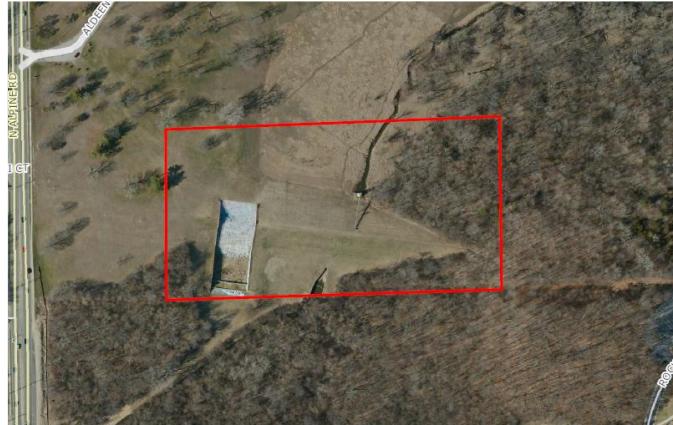
Location: 623 N. Alpine Road (Aldeen Park)

Year	Maintenance items
2014	Replacement of handrails, mowing of the embankments and removal of approximately 38 tons of accumulated silt, debris, and floatables from the trash rack and spillway.
2015	Removal of approximately 17 tons of sediment and debris, mowing of embankments. Reseeded bottom of the basin with a native prairie mix.
2016	Routine Mowing & removal of approximately 11.5 ton of sediment & debris. New trash racks were also installed.
2017	Removal of approximately 3 ton of debris from the trash rack and routine mowing.
2018	Removal of approximately 6 ton of debris from the trash rack and routine mowing.
2019	Removal of debris from trash rack. Plans developed to make upgrades in 2020.
2020	Phase 1 of the rehab project began which included paint removal, joint repair and automating the gate.
2021	Phase 1 of project is in final stages. Phase 2 is scheduled for 2022 pending IDNR review.
2022	Routine Mowing. We are still waiting for IDNR to complete their review for Phase 2 of project.

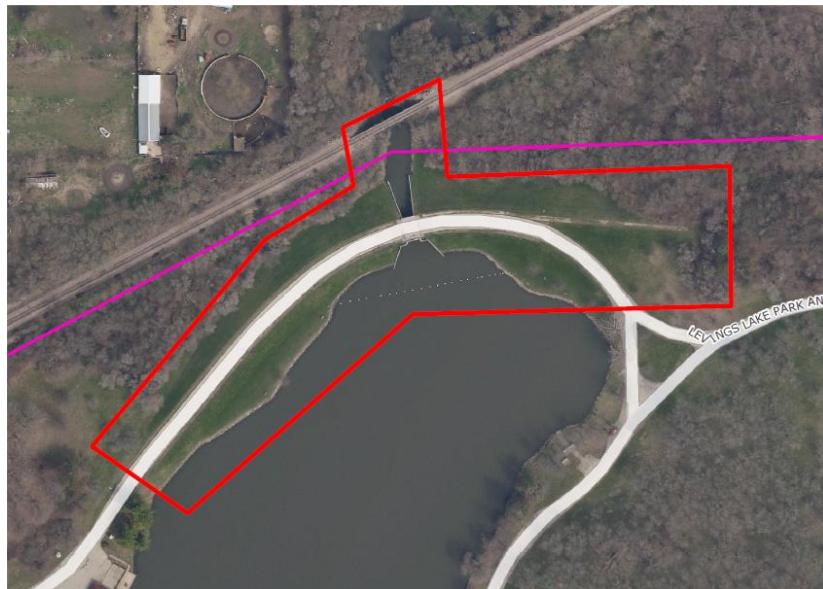
Location: South Pierpont Avenue (Levings Lake Park)

Year	Maintenance items
2014	Routine mowing of the embankments. The City installed a depth gauge.
2015	Routine mowing, tree and brush removal at the toe
2016	Routine mowing, tree and brush removal at the toe. Silt removal at the inlet of the lake
2017	Routine Mowing
2018	Routine Mowing
2019	Routine Mowing
2020	Routine Mowing and woody debris removal at the toe of the dam. An IEPA 319 grant was received to complete a watershed study which is being finalized.
2021	Routine Mowing, IEPA 319 grant is ongoing.
2022	Routine Mowing, Wetlands we expanded to south utilizing GIGO funds received by the Rockford Park District.
2023	Routine Mowing
2024	Routine Mowing
