Subject: NPDES Permit No. ILS000001

ANNUAL REPORT
Calendar Year 2018
CITY OF ROCKFORD, ILLINOIS
MUNICIPAL SEPARATE STORM SEWER SYSTEM

NPDES Permit No. ILS000001

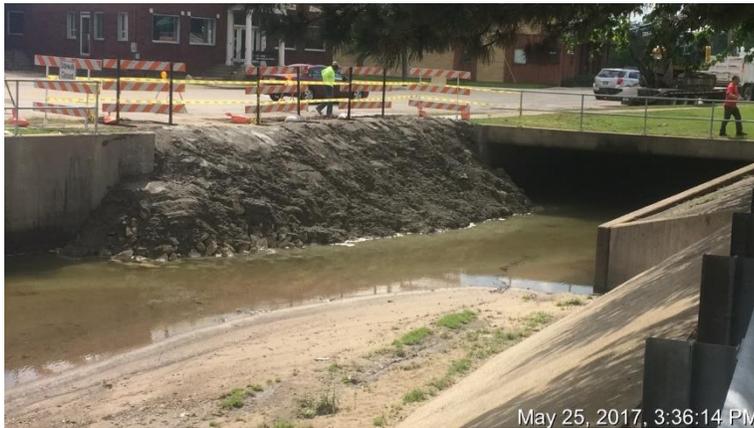
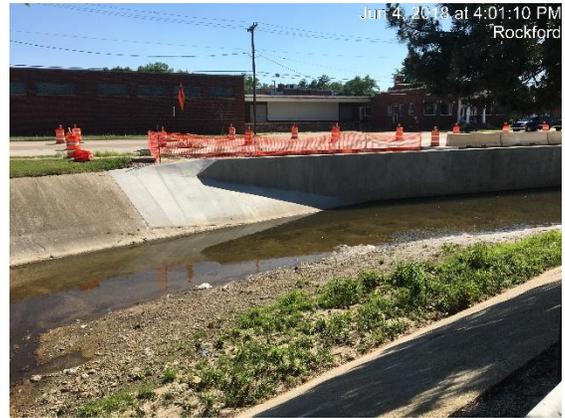
Temporary and final streambank stabilization along Keith Creek

In 2017, the City temporarily stabilized a section of Keith Creek along Charles Street where the wall collapsed and was close to damaging the sidewalk and street. This was permanently stabilized when the adjacent box-culvert was replaced in 2018. The City also began an emergency repair of a failing box culvert on Yale Drive. This will be completed in 2019.

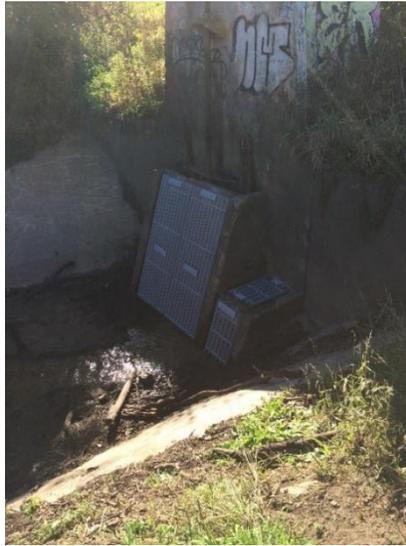
New trash racks at Alpine Dam

- The Rockford Park District removed trees and brush from Levings Lake Dam, which is along Kent Creek. Silt was also removed at the inlet of the lake.
- Trash racks were replaced at Alpine Dam in 2016. In 2018 the City entered into an Engineering Agreement with HNTB to provide plans to rehabilitate Alpine Dam.

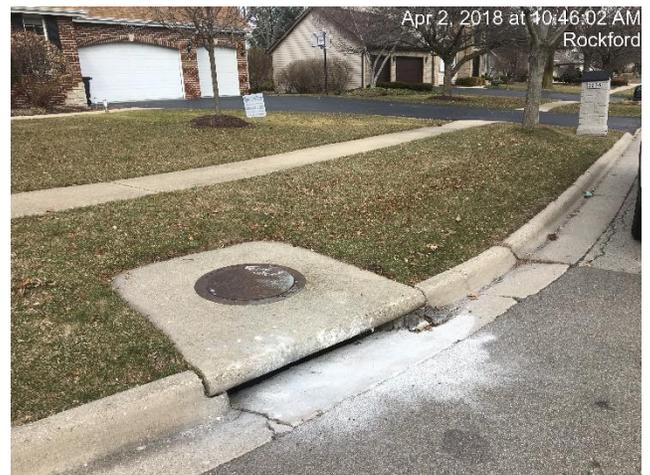
Mortar Mix dumped in inlet

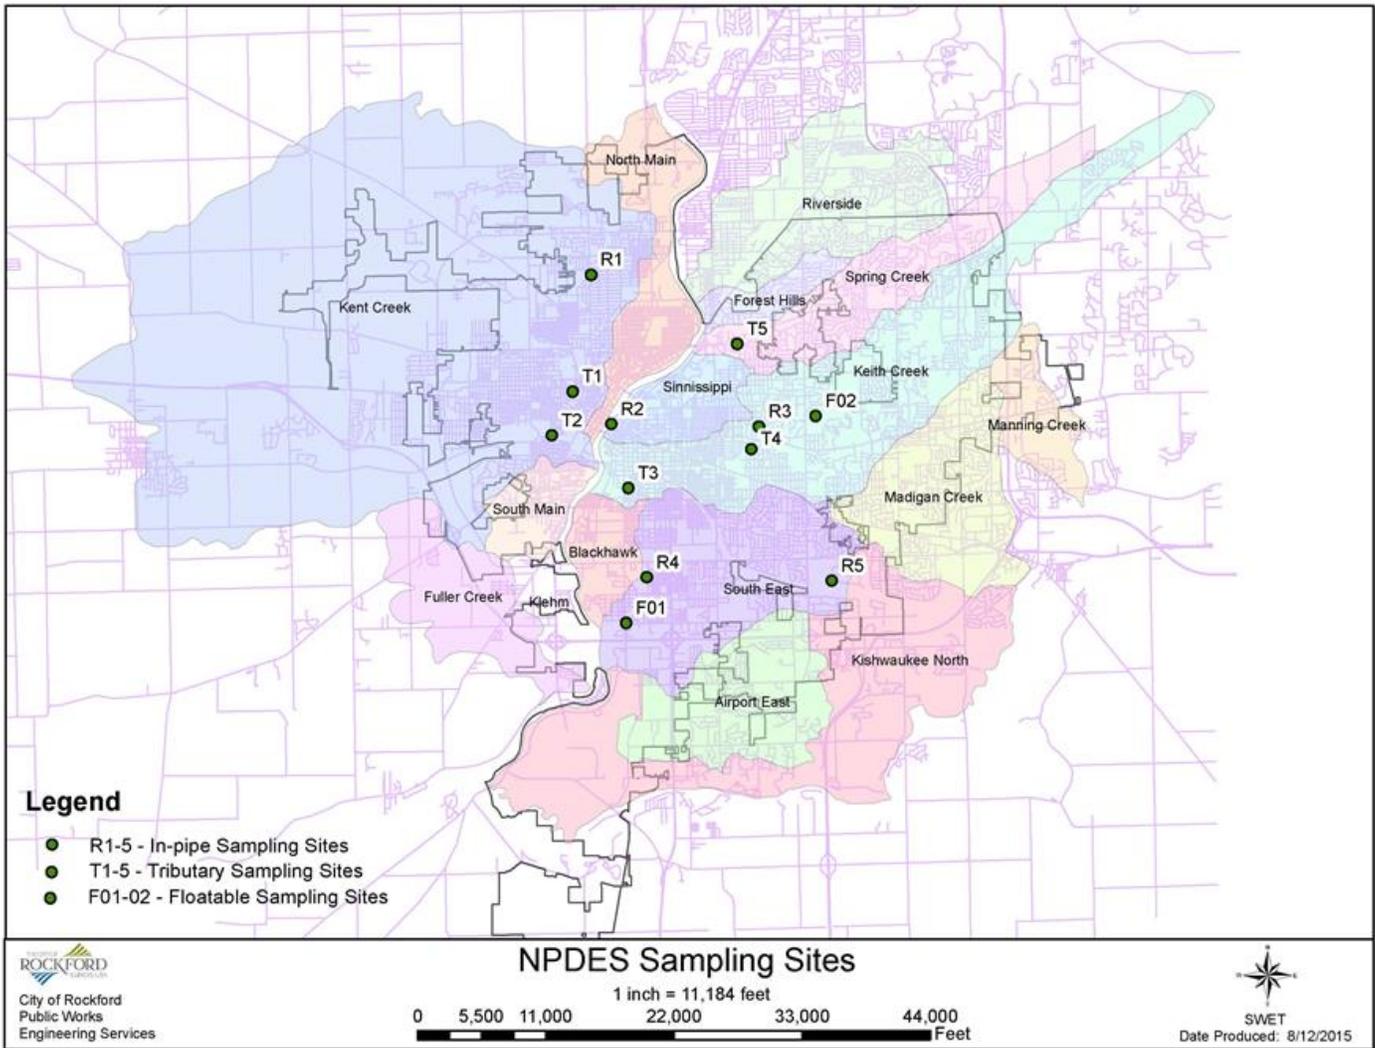
Figure A.1 Map of Stormwater and Tributary Sampling Locations

Station ID	Stream and Location
T1	North Kent Creek at Fairgrounds
T2	South Kent Creek near intersection of Tay and Corbin St
T3	Keith Creek at Tenth Avenue Park
T4	Keith Creek at Dahlquist Park
T5	Spring Creek at Starkweather Avenue

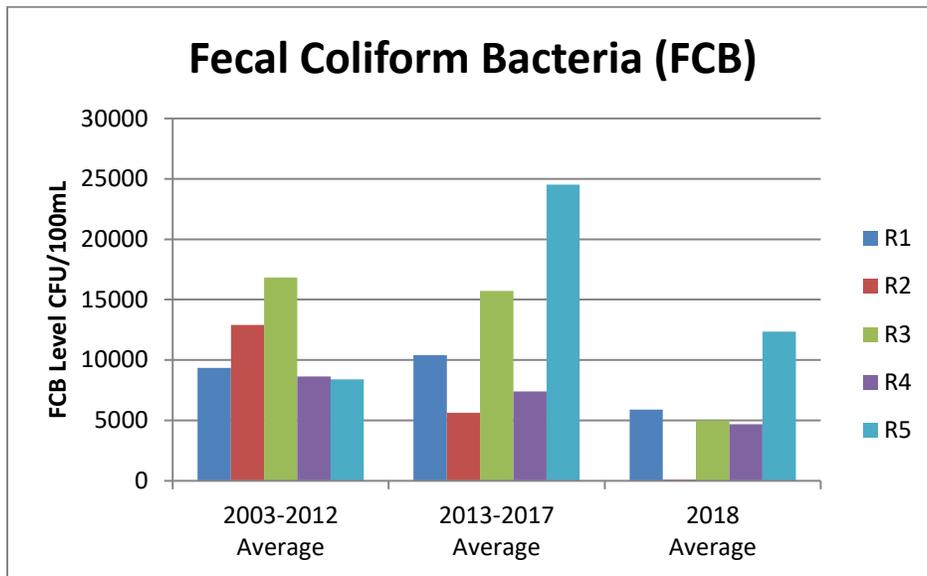
Chart B.1.1a - Storm Sewer

B.1.1a Storm Sewer Fecal Coliform Bacteria - The bacteria levels detected in the five sample locations, have been on an overall downward trend. This trend continued in 2018 and overall bacteria levels continued to decline. Outfall R5 continues to have higher levels than the other locations. As mentioned previously, there are several hypotheses on why this is the case. The FCB levels will continue to be monitored in the future for sources and trends. Typical wastewater discharge objectives are as low as 400 CFU/100ml.

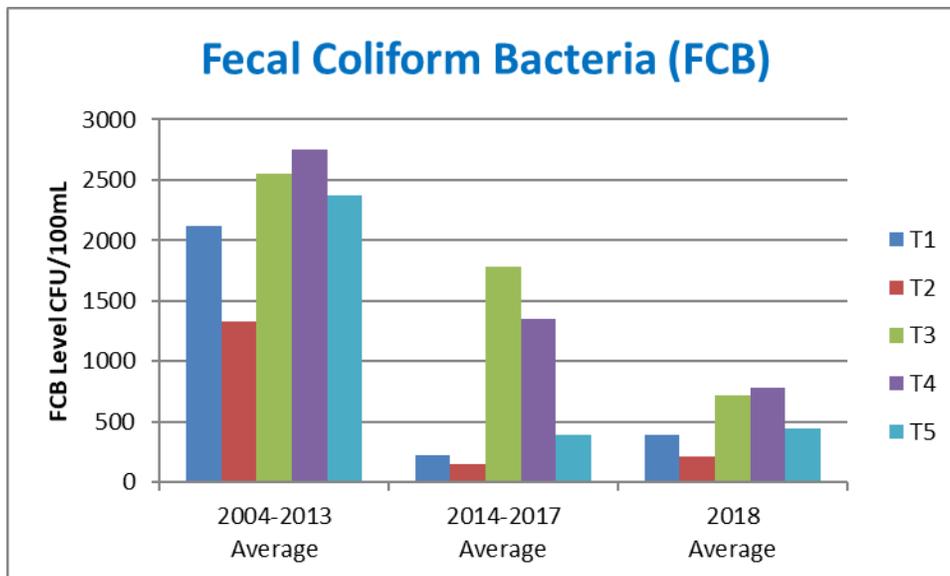
Chart B.1.1b - Tributary

B.1.1b Tributary Fecal Coliform Bacteria - Bacteria levels in the streams continued a relative downward trend 2018. About one-third of the samples were over 400 CFU/100ml, an objective level for surface waters. Some locations (T1, T2, & T5) had slightly elevated levels from the past five-year averages, but other (T3 & T4) were down considerably. The samples were collected in lower flow periods. Historically, when higher bacteria levels were encountered, the flows were higher (wet weather), indicating land runoff containing animal droppings.

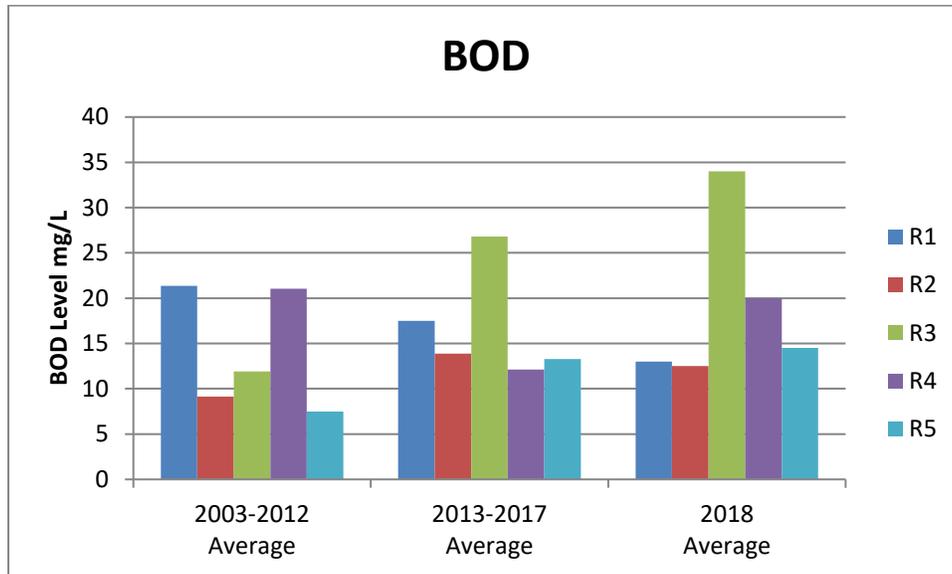
Chart B.1.2

B.1.2 Biochemical Oxygen Demand - The five-day Biochemical Oxygen Demand (BOD) is a measure to determine the need of the water to decompose organic matter. The greater the need for oxygen, the more oxygen that will be pulled from the receiving water source, thus reducing the oxygen content of the water. When organic loadings remove oxygen from the water, more favorable natural organisms (aquatic bugs, crustaceans, fish, etc.) are reduced in number. Typically, BOD levels of less than 30 mg/l are acceptable for wastewater discharge. R3 had one sample event with a result of 39mg/l. If this trend continues an investigation may be warranted.

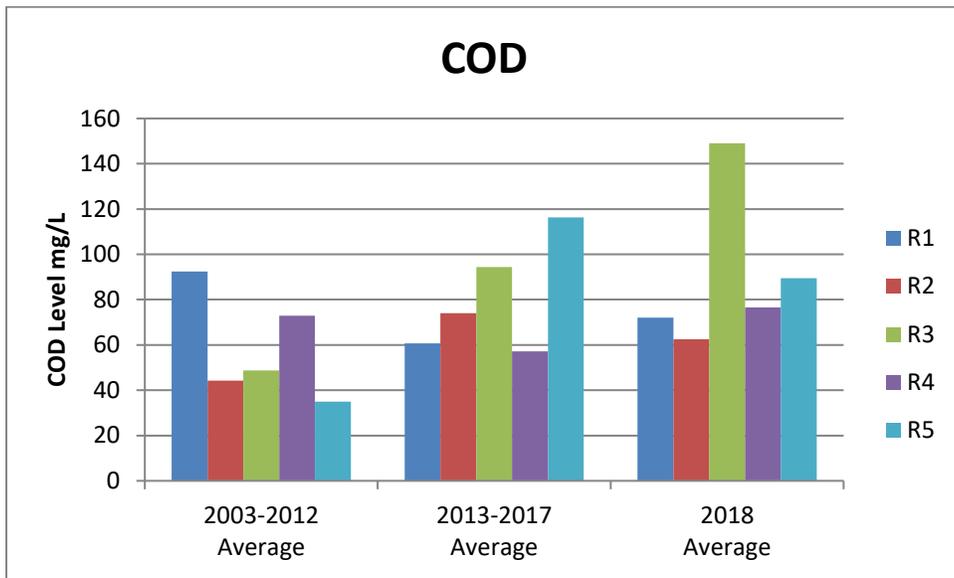
Chart B.1.3a - Storm Sewer

B.1.3a Storm Sewer Chemical Oxygen Demand - The Chemical Oxygen Demand (COD) is a measure of the total oxygen needs of all chemicals (inorganic and organic matter) in the water. The COD levels tend to be 10 to 100 percent higher than BOD, which only measures what can naturally biodegrade. High COD readings can indicate chemical contamination versus an organic contamination. COD results were in line with historical concentrations. Concentrations tend to be slightly higher in the spring.

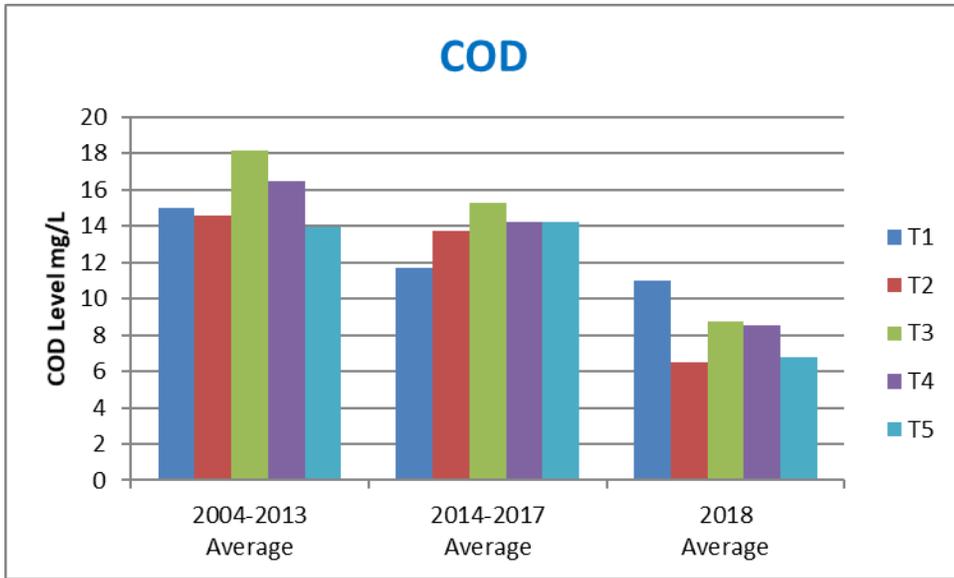
Chart B.1.3b - Tributary

B.1.3b Tributary Chemical Oxygen Demand - There appears to be a decrease in COD levels in 2018 from historical levels. The average levels of 6 to 11 mg/L are excellent.

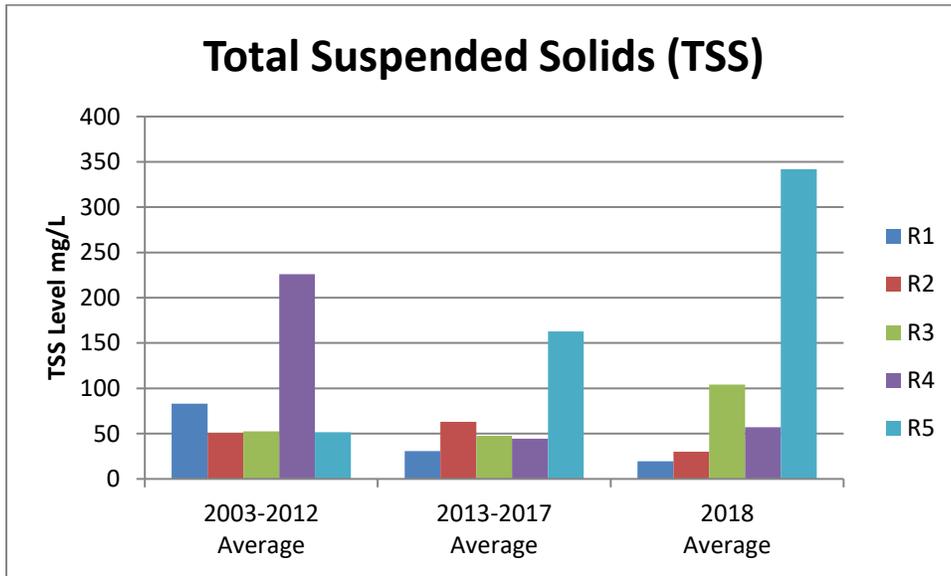
Chart B.1.4a - Storm Sewer

B.1.4a Storm Sewer Total Suspended Solids - Total Suspended Solids (TSS) is a measure of the particulates being carried in the water. Based upon the analyses, the amounts detected have generally been trending down or have remained similar. If you look at the details for each outfall, you will notice the TSS results were highest in the spring with the first major rainfall event after winter. We would suspect this may be a direct result of sand/grit privately applied during the winter to roadways and sidewalks. The City of Rockford stopped applying grit several years ago. The 2018 average concentrations were within historical levels, with one exception, R5 was very high in the March sample event (634mg/l). A source was not identified for the high TSS.

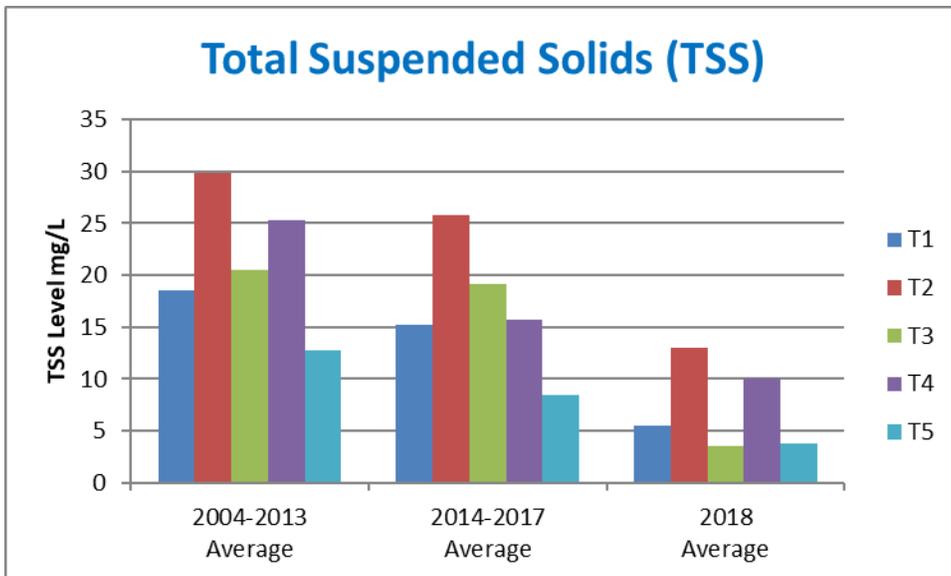
Chart B.1.4b - Tributary

B.1.4b Tributary Total Suspended Solids - Suspended solids decreased in 2018 compared to recent history. T1 and T5 were back to lower levels compared to 2017.

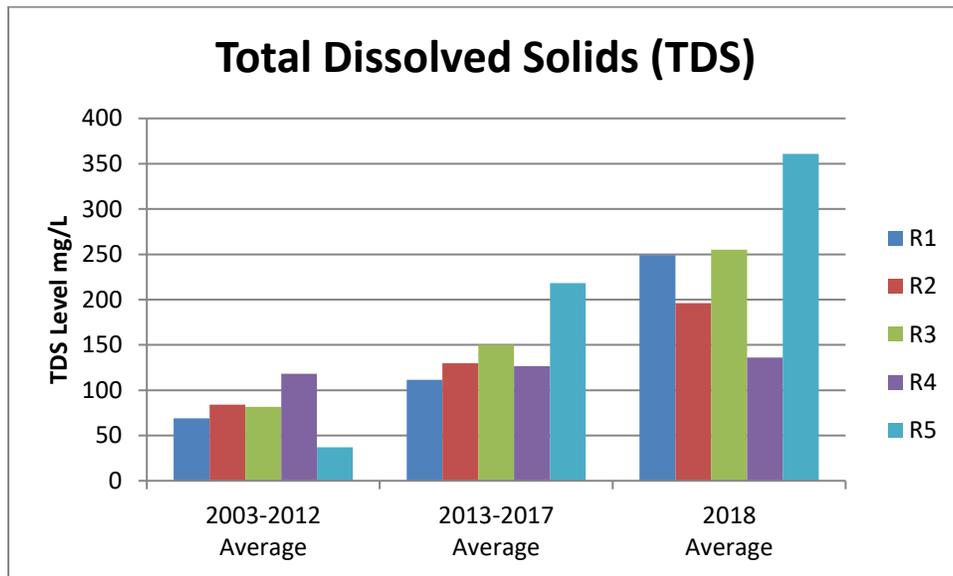
Chart B.1.5a - Storm Sewer

B.1.5a Storm Sewer Total Dissolved Solids - Total Dissolved solids (TDS) is a measure of all inorganic and organic substances dissolve in the water. For instance, salt would dissolve in water and elevate the content of TDS. The average TDS concentrations for the five outfalls ranged from about 150 to 350 mg/l. The graph indicates higher levels compared to recent samples. You can see a trend of the first spring samples tending to have the highest TDS, believed to be caused by salt residues from winter. In the 2018 spring samples, there may have been higher salt residues from winter applications, than have historically been present.

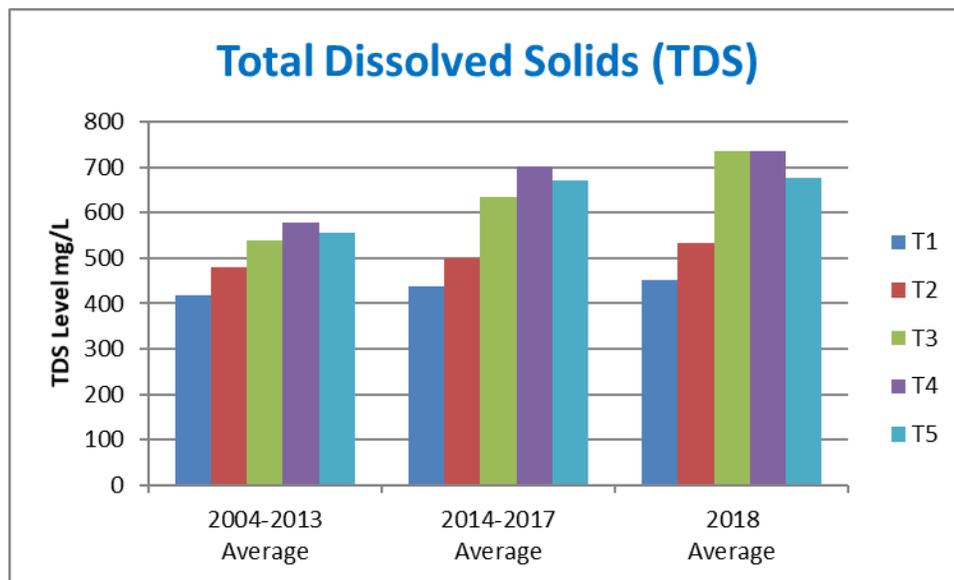
Chart B.1.5b - Tributary

B.1.5b Tributary Total Dissolved Solids - The dissolved solids levels were comparable to historical levels. There is a good correlation between dissolved solids and conductivity levels; salt levels drive both numbers. Tributary sample zones T3, T4, and T5 all have more commercial parking areas with salt application. There are no standards to compare these levels to in Illinois.

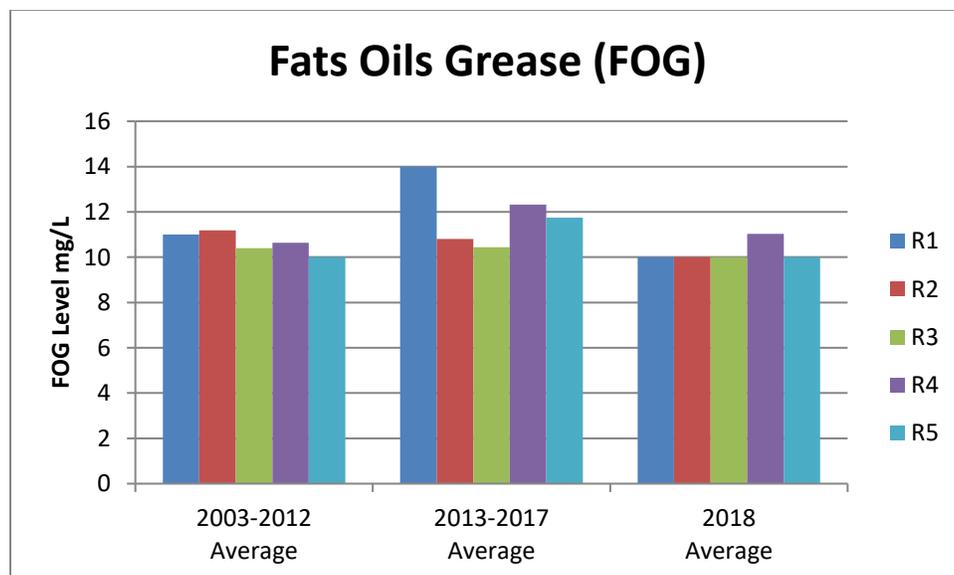
Chart B.1.6

B.1.6 Fats Oils and Grease - Stormwater is analyzed for the presence of Fats, Oils, and Grease (FOG) to assess the impacts from human activities. Industrial and automotive activities would be the sources of elevated numbers. Fortunately, FOG results have been very stable and within a normal range. Typical industrial discharge limits are 15 mg/l and the 2018 average discharge amounts were 10 to 11 mg/l, with 10 being the analytical detection level.

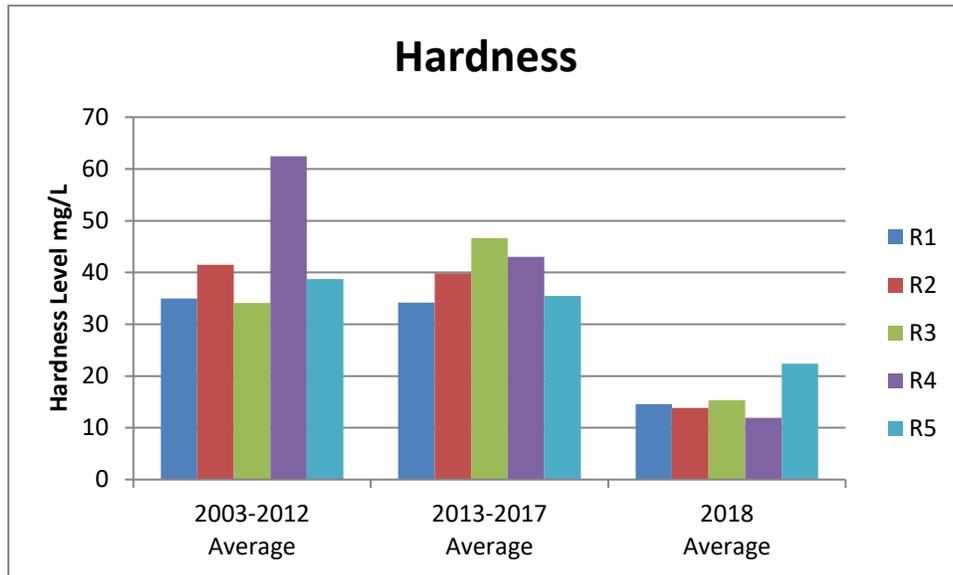
Chart B.1.7

B.1.7 Hardness - Water hardness is monitored as an indicator of water quality and the presence of some metals. Water hardness in 2018 was lower than historical numbers with a range of 12 to 22 mg/l (as CaCO₃) in the stormwater. Hardness levels of under 600 would be normal for surface waters in the region, due to limestone stream sources. Storm sewer water should be primarily rainwater, and this would have low hardness.

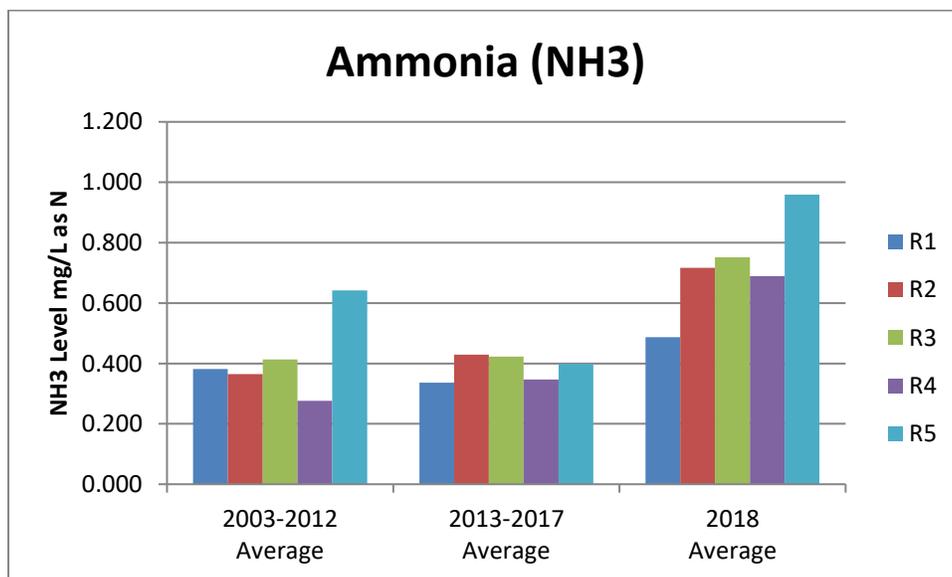
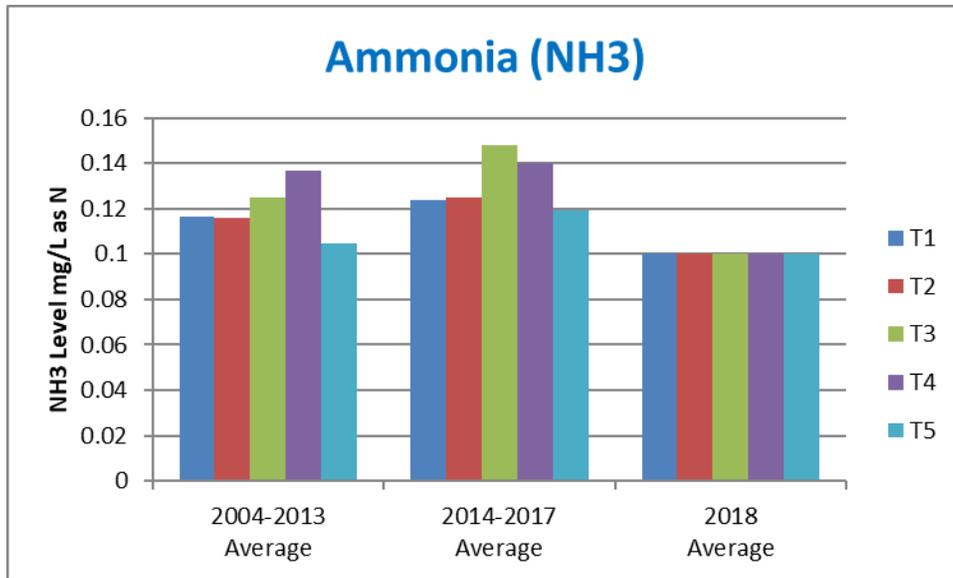
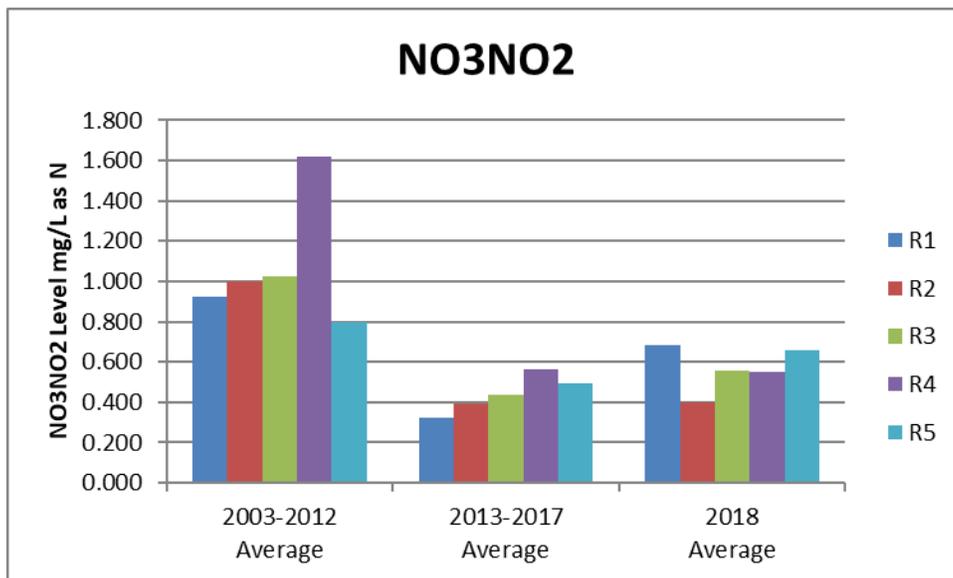
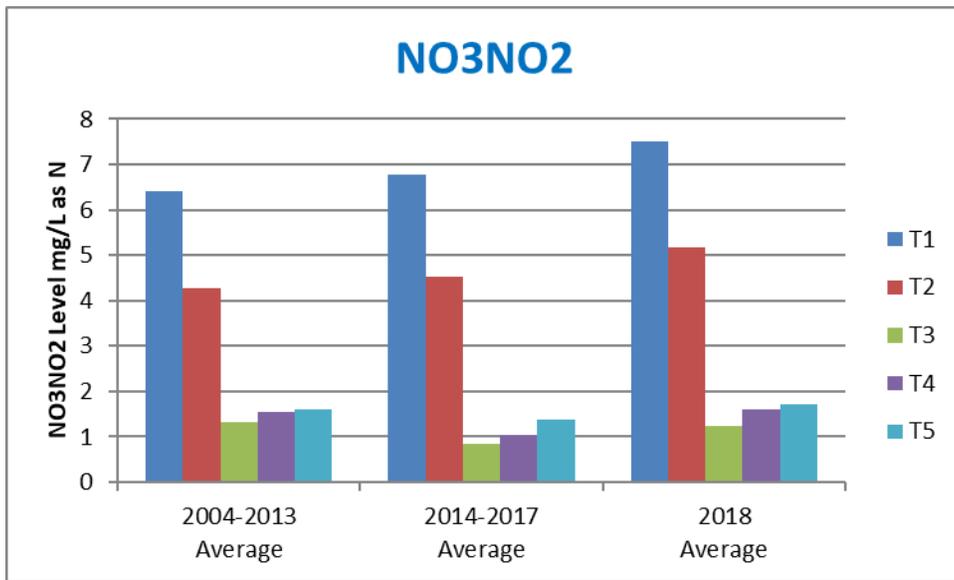
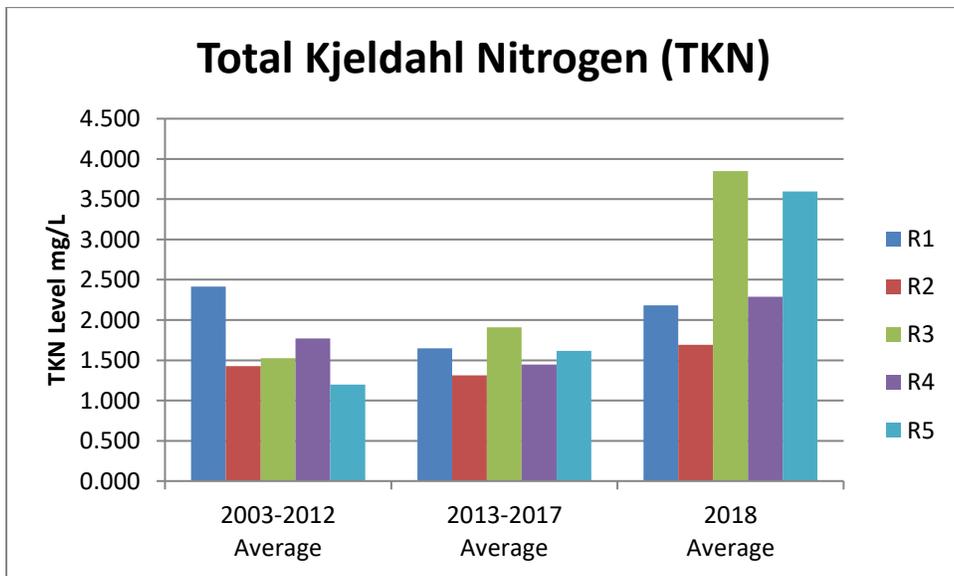
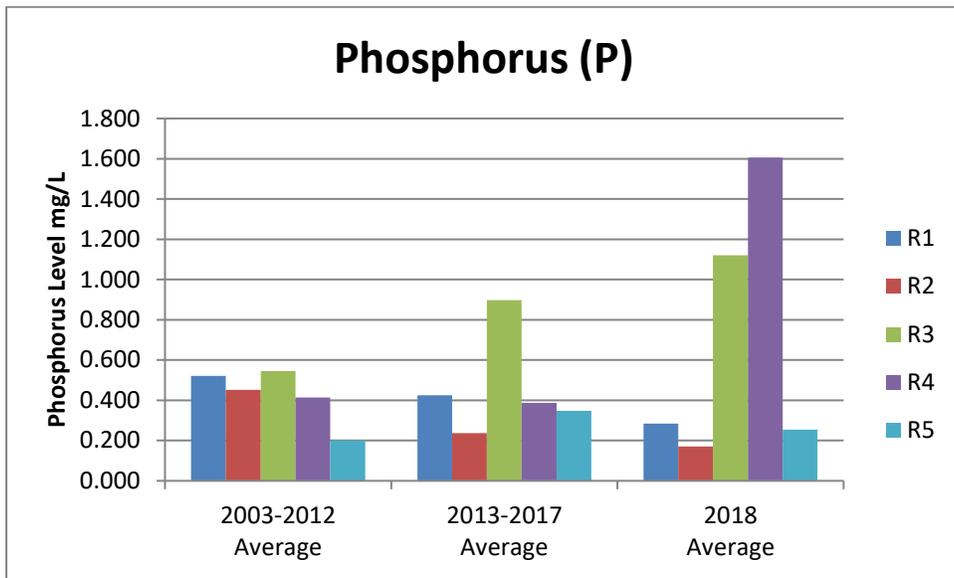
B.1.8c Comparison of Storm Water vs. Tributary - Ammonia levels in the storm sewer are about five times that of tributaries. Nitrate and nitrite levels are about double or more in the tributary samples as compared to the storm sewer samples. Phosphorus levels in the storm sewer are about twice that of the tributary levels.

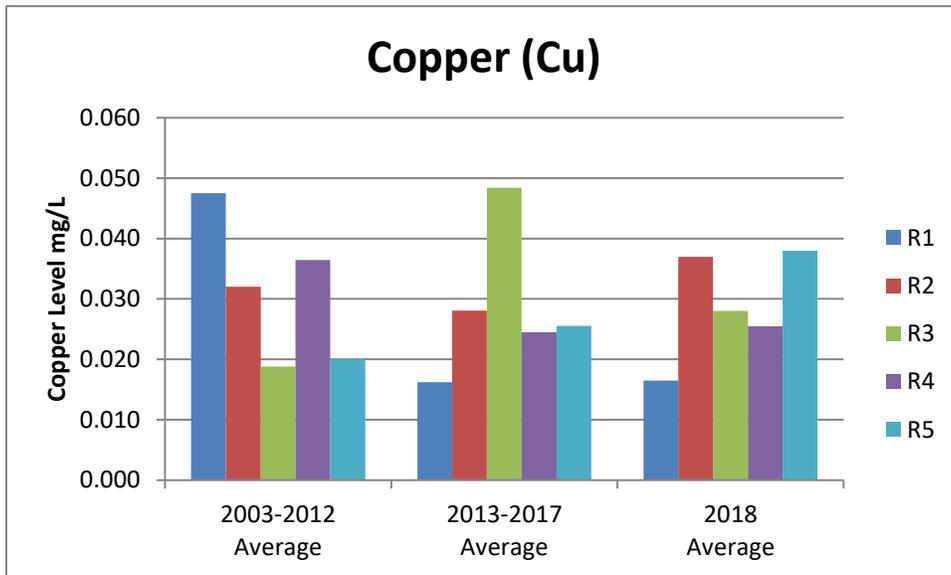
Chart B.1.9a - Storm Sewer

Note: April 13, 2014 copper results are suspect and were removed from data.

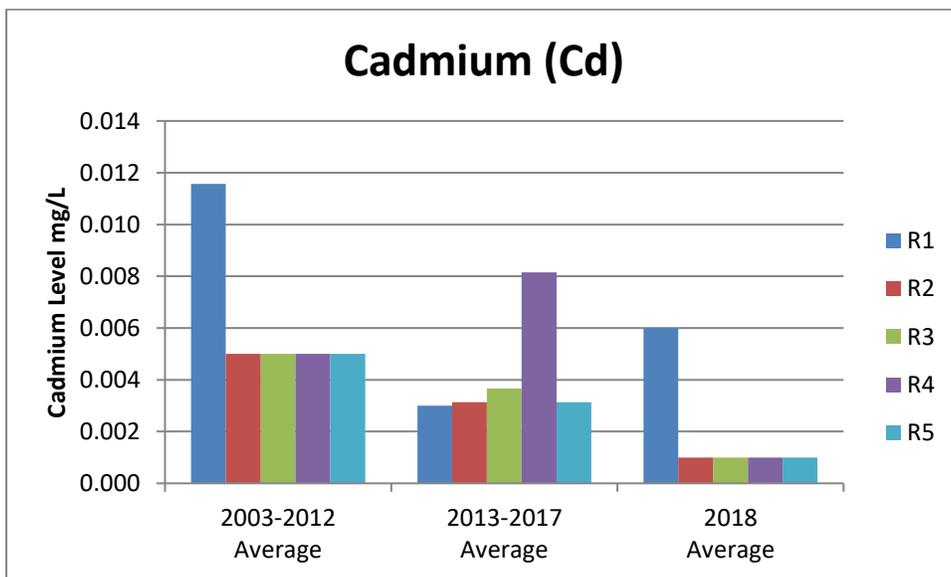
Chart B.1.9b - Storm Sewer

Note: April 13, 2014 cadmium result for outfall R3 was suspect and removed from data.

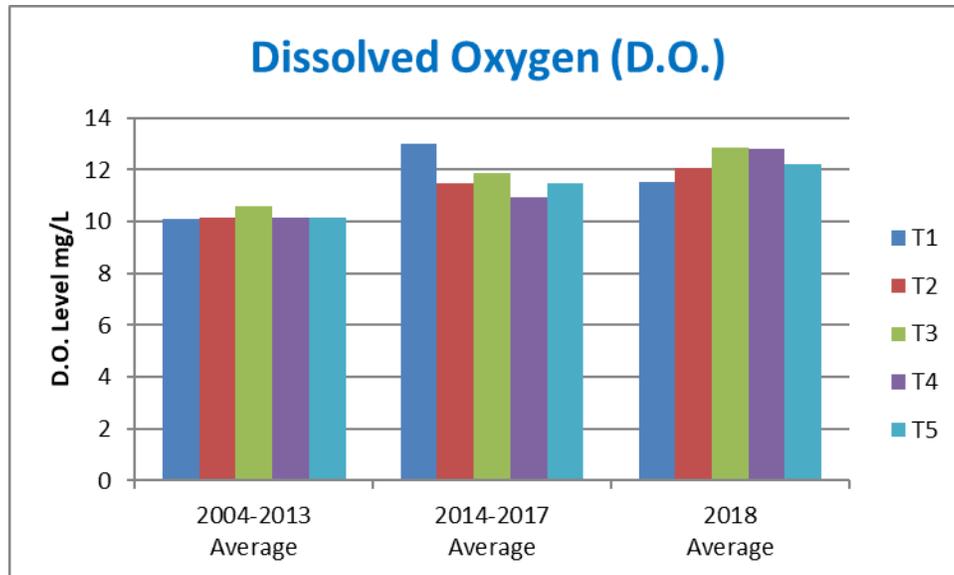
Chart B.1.10a - Tributary

B.1.10a Dissolved Oxygen - The levels of dissolved oxygen in the stream are very good. Average stream levels are above 10.0 mg/L. General Use Water Quality Standards strive to see numbers above 6.25 mg/L and never lower than 4.0 mg/L in the summer. There was one reading on 8/13/18 where T1 was recorded as 3.2 mg/l, this is believed to have been an analytical or recording error. High/favorable DO measurements indicate low oxygen demand and minimal sewage or organic loads.

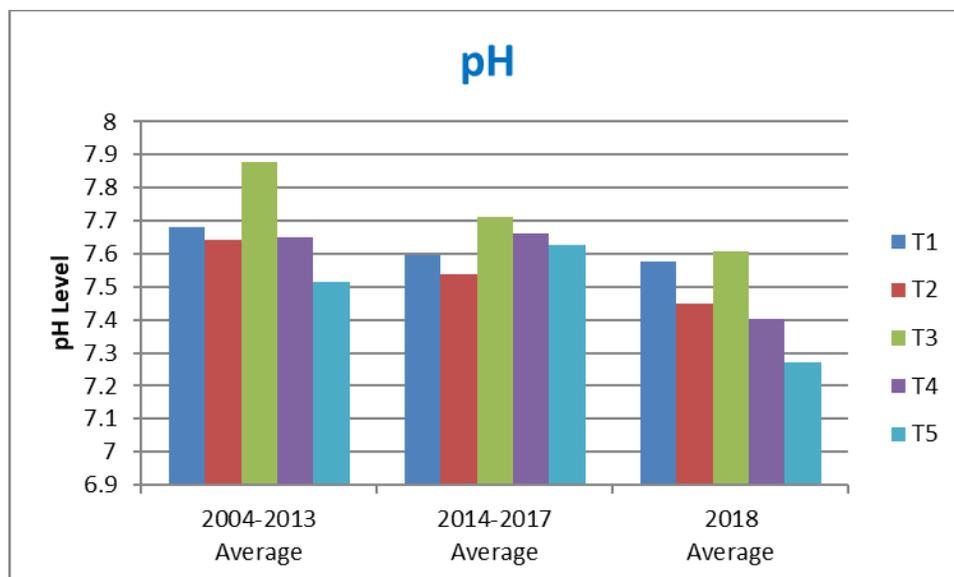
Chart B.1.10b - Tributary

B.1.10b pH - The General Use Water Quality Standard provides an acceptable range of 6.5 to 9.0. For 2018, the pH range of all samples was 7.01 to 8.11. All these numbers are within the normal range of surface water.

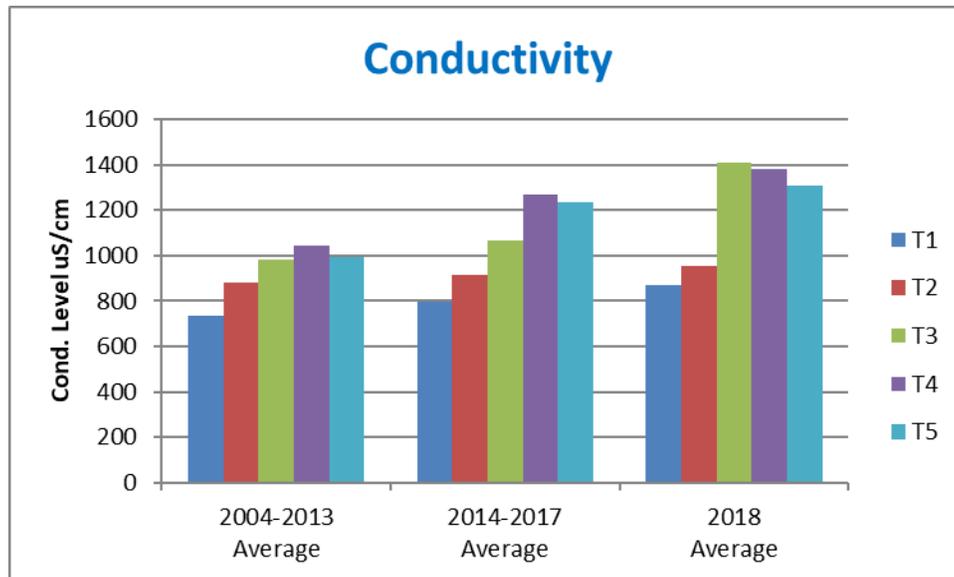
Chart B.1.10c - Tributary

B.1.10c Conductivity - The results demonstrate average levels of 800 to 1500. Conductivity is the measure of ions (salts) dissolved in the water. Stream samples at T1 and T2 on average are lower. This is probably due to less commercial and industrial activities with salt applications on the roads and parking lots. The drainage areas of T1 and T2 are more residential and agricultural. Salt is probably the primary contributor to elevated conductivity and is evident by the elevated levels during the winter.

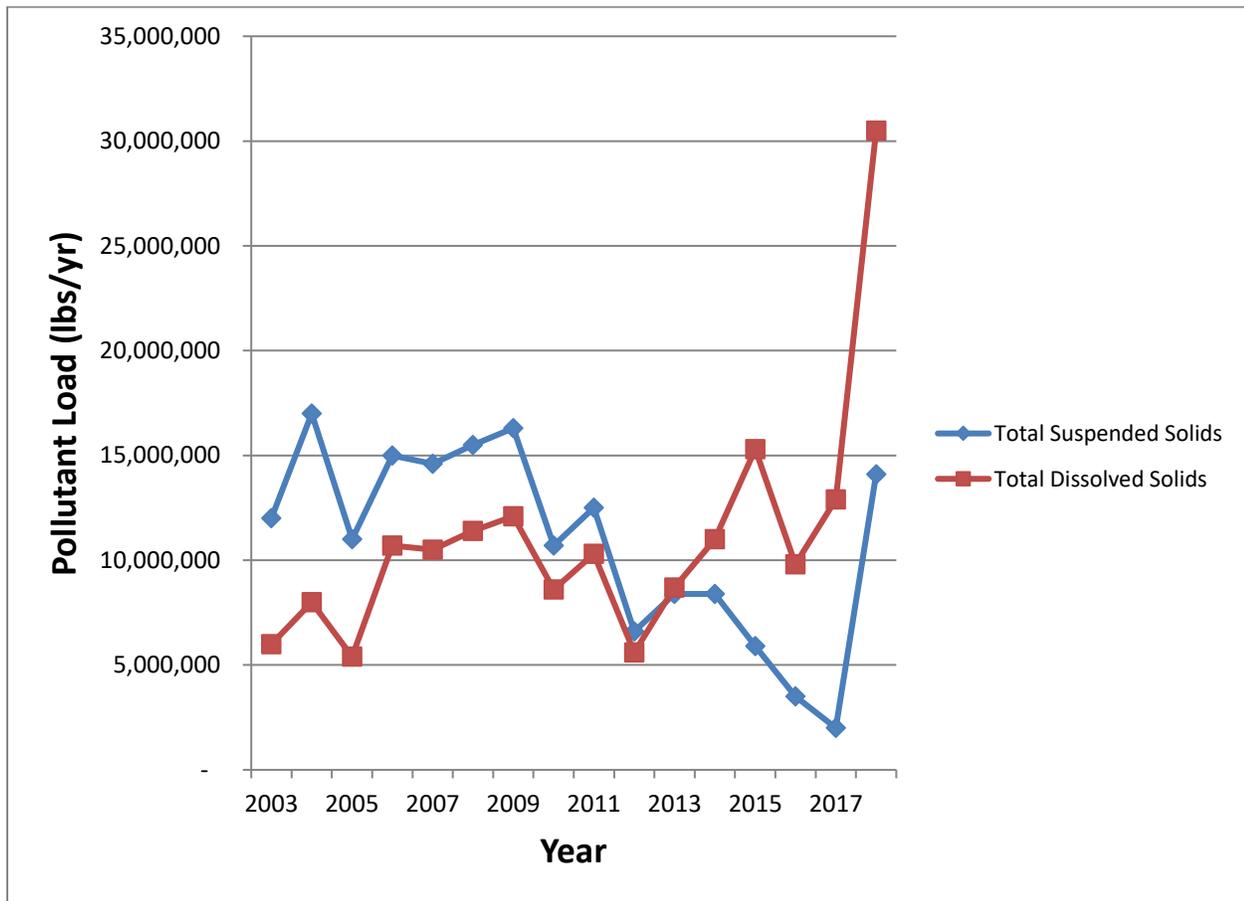
Graph B.3.1

B.3.1 Annual Solids Loading - Solids loading to the streams has been on a downward trend for suspended solids. This may be the result of discontinued practices by the City for grit applications. There was a reversal in this trend in 2018, back to near historical loadings. The dissolved solids loadings had been increasing the past few years and spiked in 2018 due to the increased volume of stormwater and the higher concentrations of dissolved solids. This upward trend could be the result of increased salt application, due to the fact concentrations are three to four times higher in the spring.

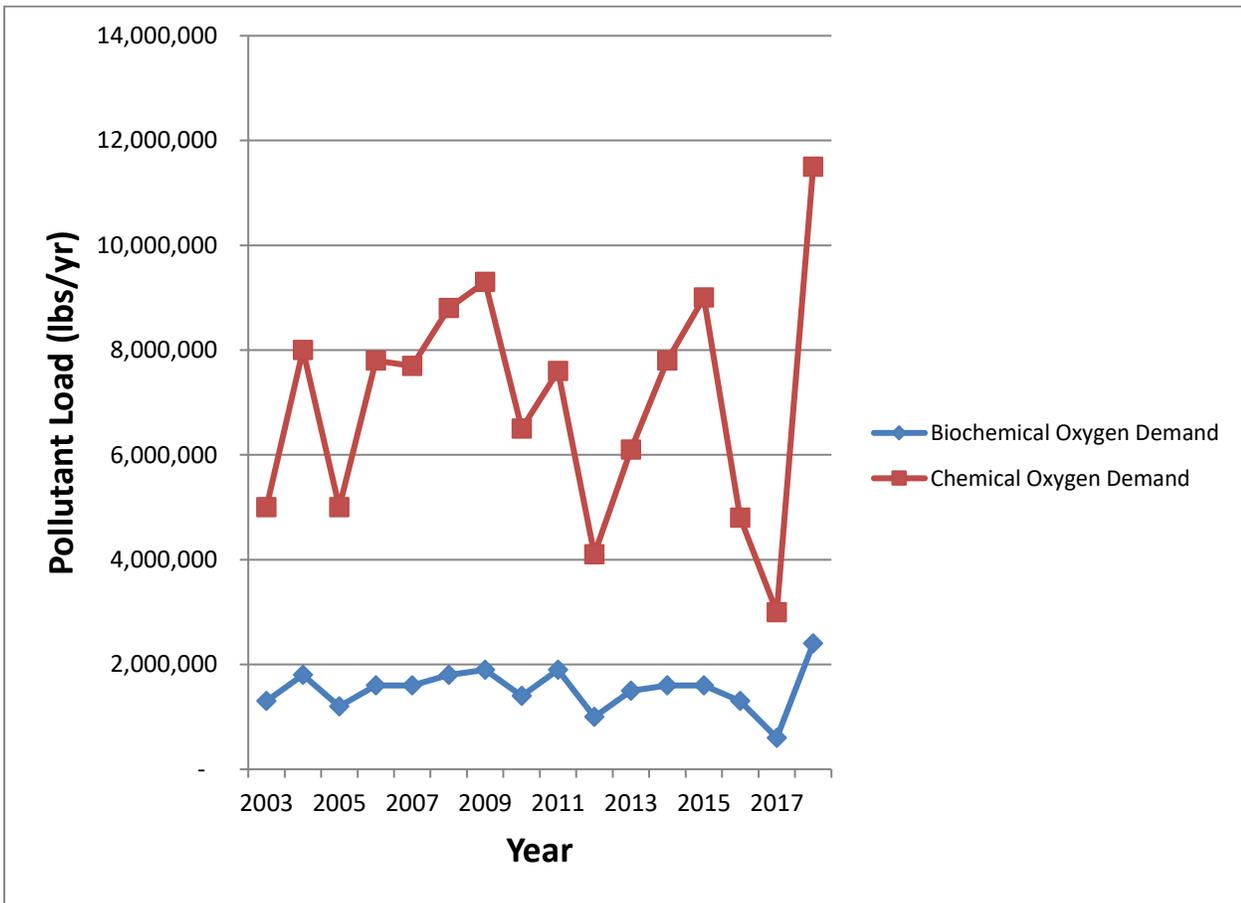
Graph B.3.2

B.3.2 Oxygen Demand - The oxygen demand over time has stayed very similar from one year to the next. BOD has little variation, but COD has some larger swings in the loading values.

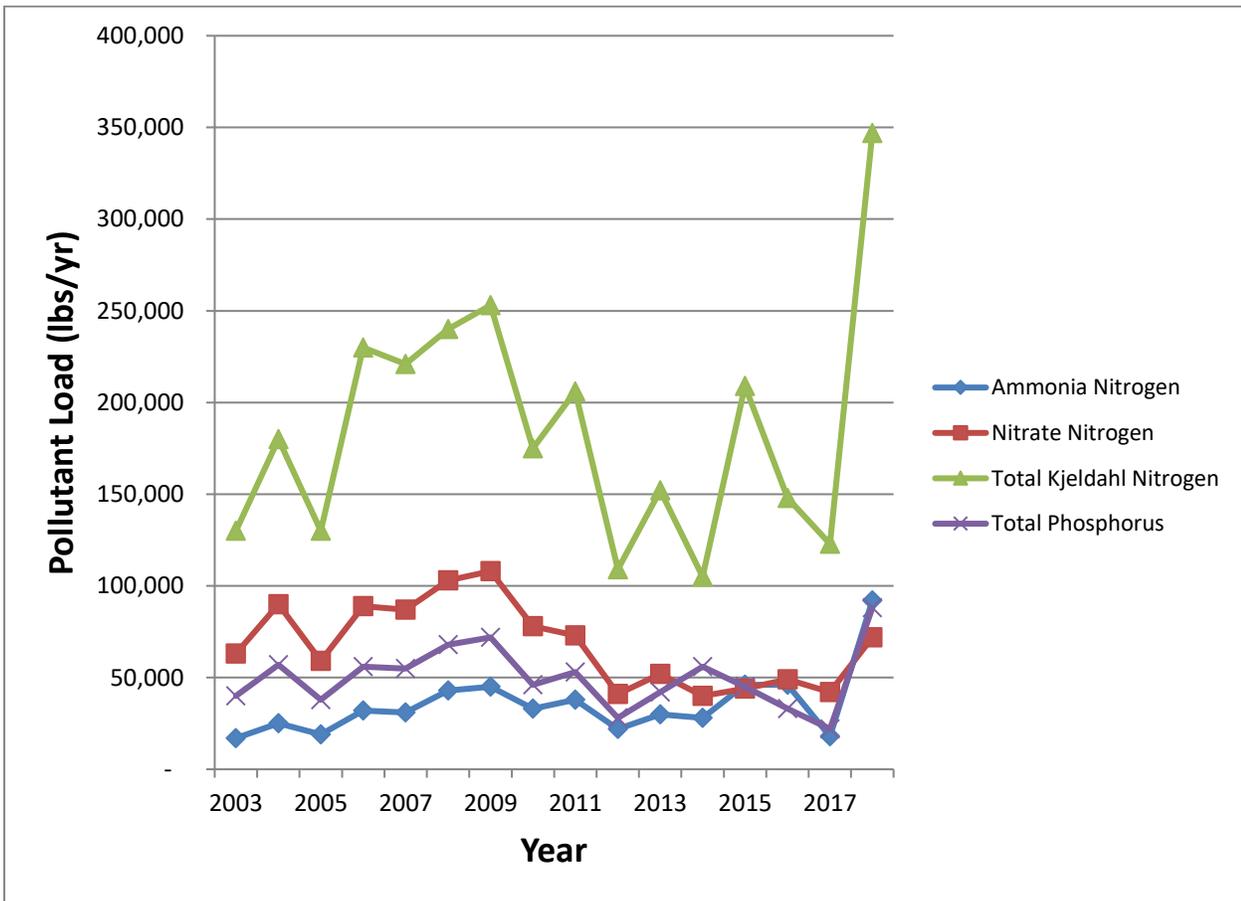
Graph B.3.3

B.3.3 - Nutrient Loadings - The nutrient loadings from the City appear to be stable with minor fluctuations from one year to the next. 2018 saw an increase in all parameters.

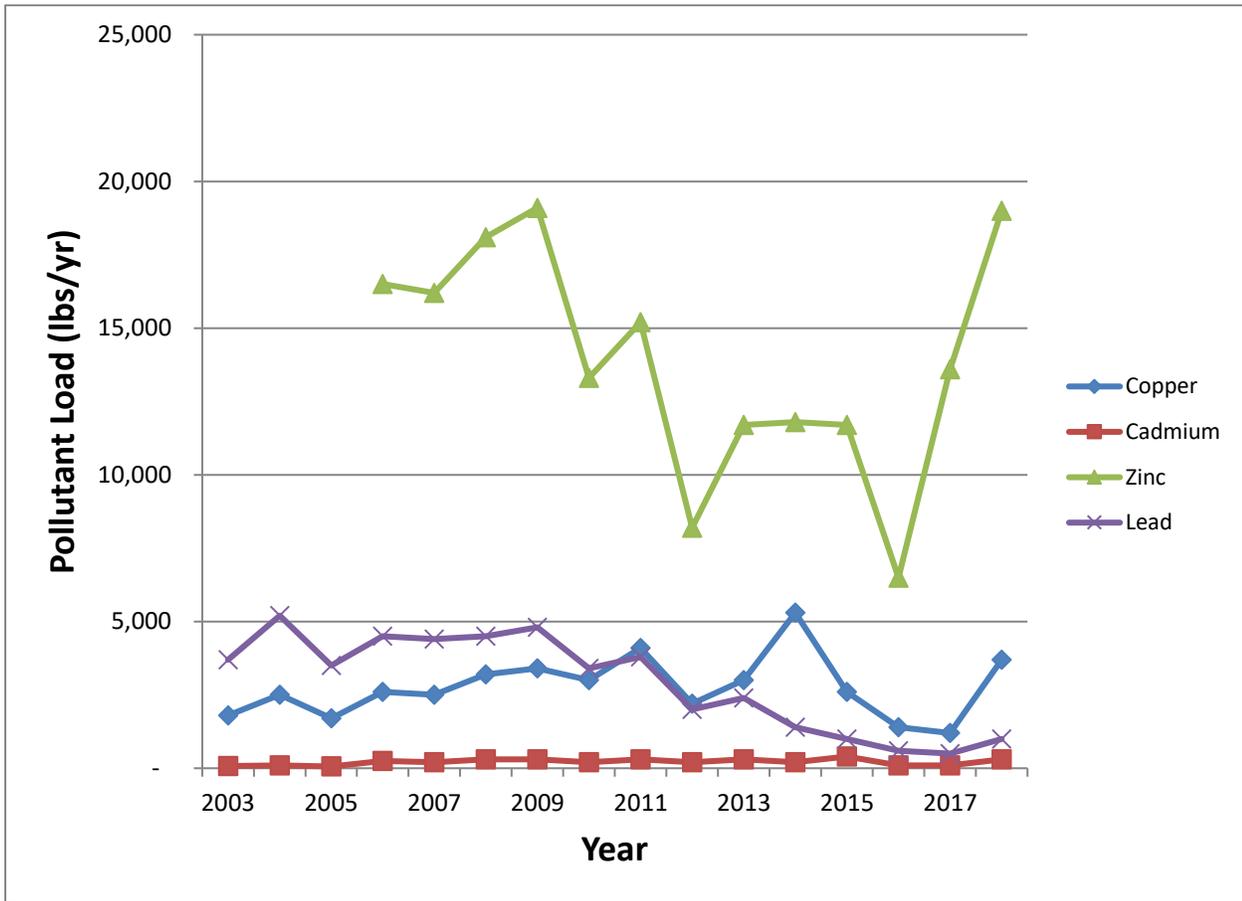
Graph B.3.4

B.3.4 Metals Loading - The metal loadings have shown a slight decreasing trend in recent history. But 2018 had increased loading, primarily due to the increased amount of precipitation. Copper and cadmium have been relatively stable.

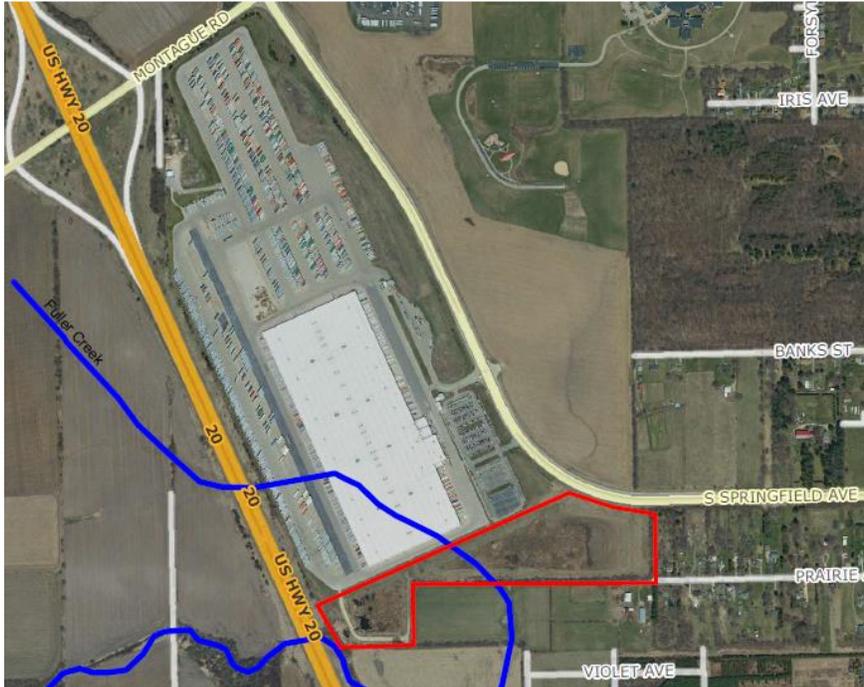
Location: SE Springfield Ave & Montague Rd.

Maintenance Responsibility: City of Rockford (structural),
Lowes (mowing)

Year	Maintenance
2012	Routine Mowing
2013	Routine Mowing
2014	Routine Mowing
2015	Routine Mowing
2016	Routine Mowing
2017	Routine Mowing
2018	Routine Mowing

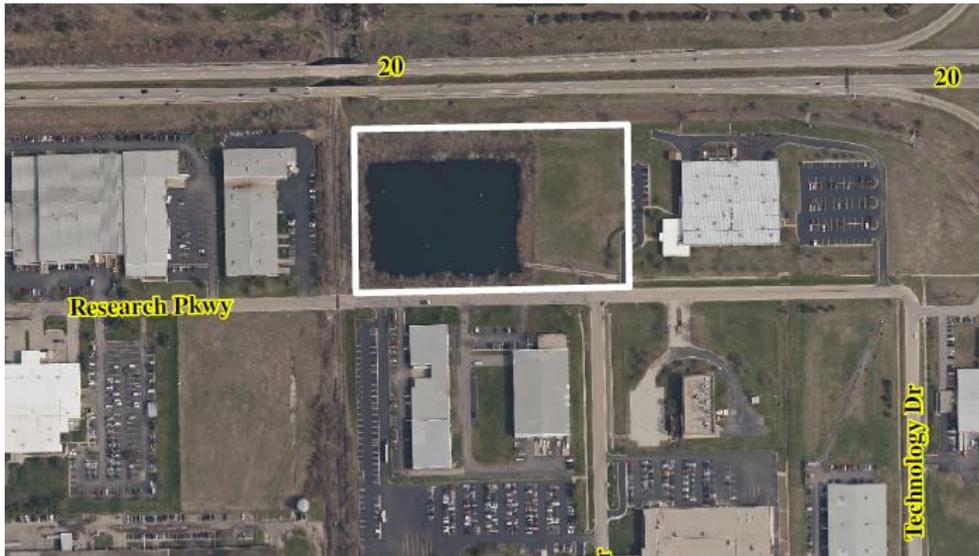
Location: 1052 Research Parkway

Maintenance Responsibility: City of Rockford

Year	Maintenance
2012	Routine Mowing
2013	Routine Mowing
2014	Routine Mowing
2015	Routine Mowing
2016	Routine Mowing
2017	Routine Mowing
2018	Routine Mowing
