Subject: NPDES Permit No. ILS000001

ANNUAL REPORT
Calendar Year 2018
CITY OF ROCKFORD, ILLINOIS
MUNICIPAL SEPARATE STORM SEWER SYSTEM

NPDES Permit No. ILS000001

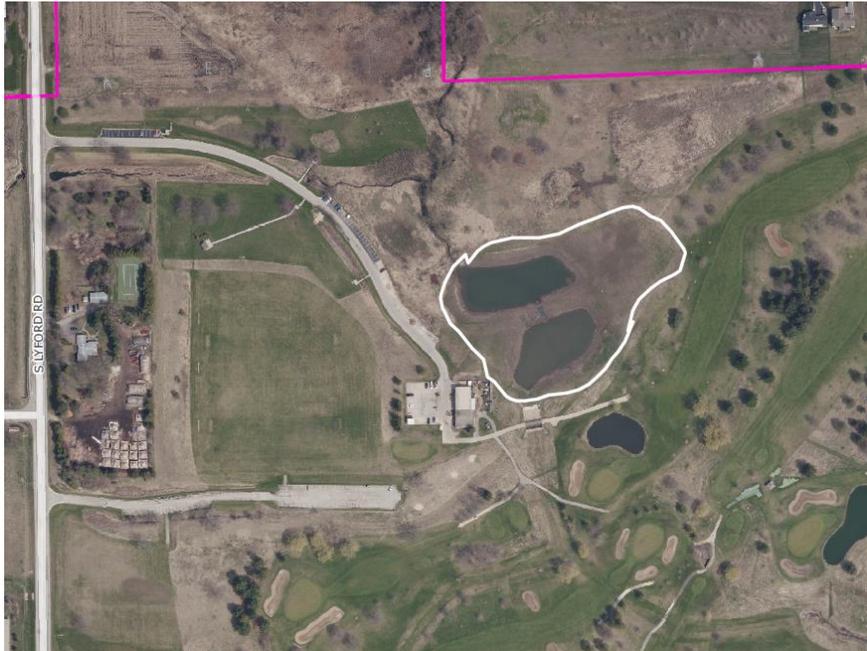
Location: 888 South Lyford Road

Maintenance Responsibility: City of Rockford (structural),
Rockford Park District (weekly)

Year	Maintenance
2008	Routine Mowing, Basin dredged, reshaped, sediment basin constructed
2009	Routine Mowing
2010	Routine Mowing
2011	Routine Mowing
2012	Routine Mowing, minor erosion repaired and reseeded
2013	Routine Mowing
2014	Routine Mowing
2015	Routine Mowing
2016	Routine Mowing, debris removal
2017	Woody debris removal, pipe repair, erosion repair and stabilization
2018	Routine Mowing

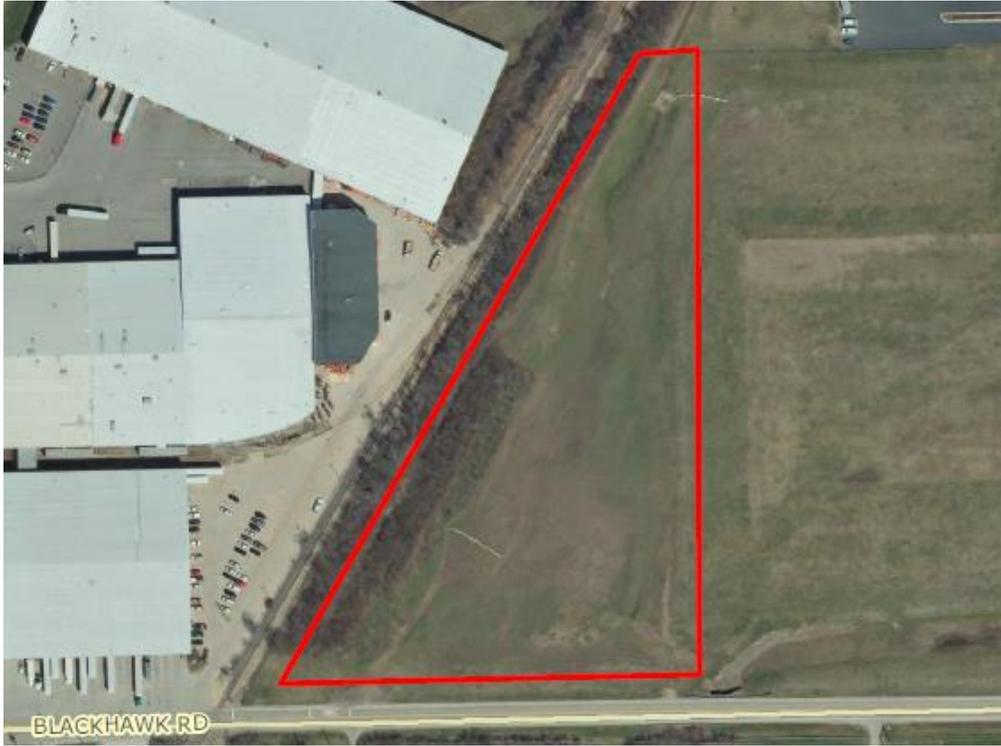
Location: 1650 Blackhawk Road

Maintenance Responsibility: City of Rockford

Year	Maintenance
2009	Detention Basin Constructed
2010	None
2011	None
2012	None
2013	Construction began to complete basin design with local contractor
2014	Basin construction completed. Additional designs underway for retrofit
2015	Dry wells installed for better drainage, Routine Mowing
2016	Routine Mowing
2017	Routine Mowing
2018	Routine Mowing

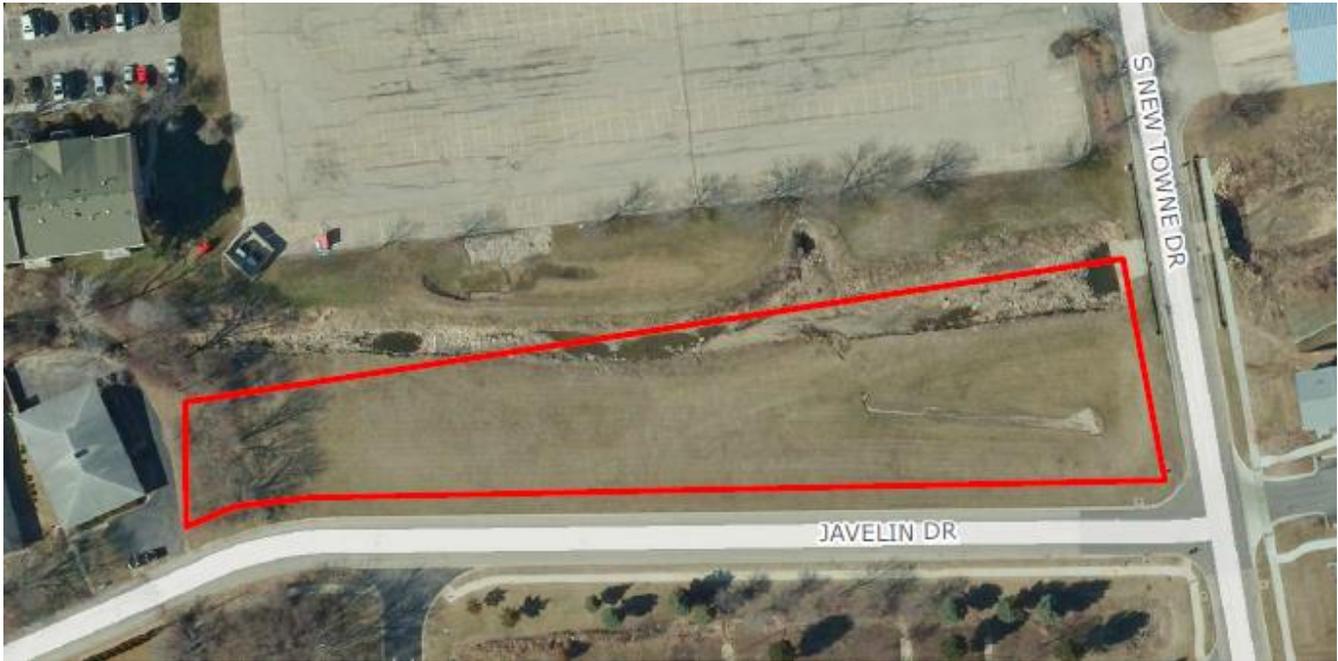
Location: NW New Towne and Javelin Drives

Maintenance Responsibility: City of Rockford

Year	Maintenance items
2014	Removed 37.66 tons of sediment from concrete channel and reseeded and routine mowing
2015	Routine Mowing
2016	Removal of 1 ton of sediment and added riprap to prevent erosion. Routine Mowing
2017	Routine Mowing
2018	Routine Mowing

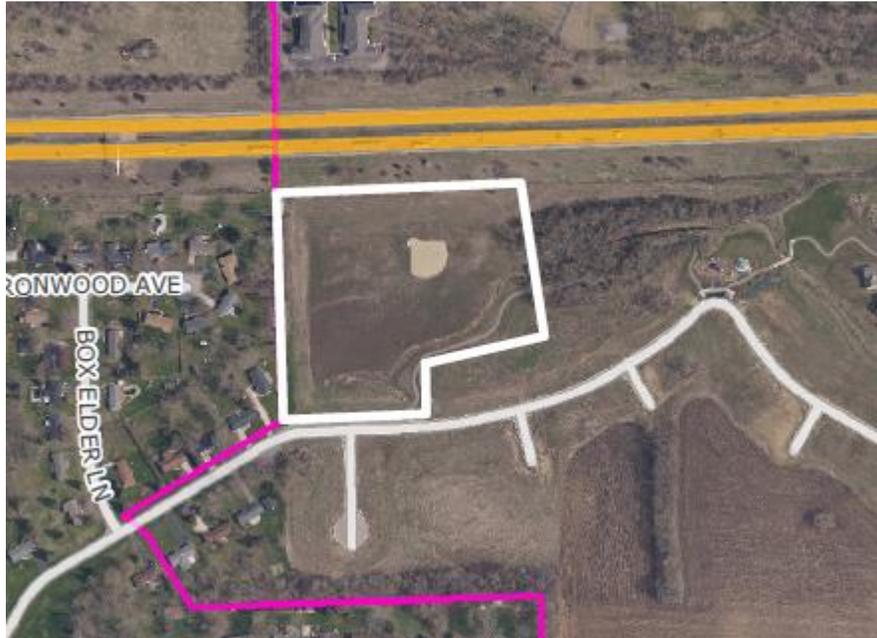
Location: Scarlet Oak Drive and Bypass 20

Maintenance Responsibility: City of Rockford (structural)
Rockford Park District (routine maintenance)

Year	Maintenance items
2012	Routine Mowing
2013	Routine Mowing & tree removal
2014	Routine Mowing
2015	Routine Mowing & tree removal
2016	Routine Mowing & repairs to berm.
2017	Routine Mowing
2018	Routine Mowing

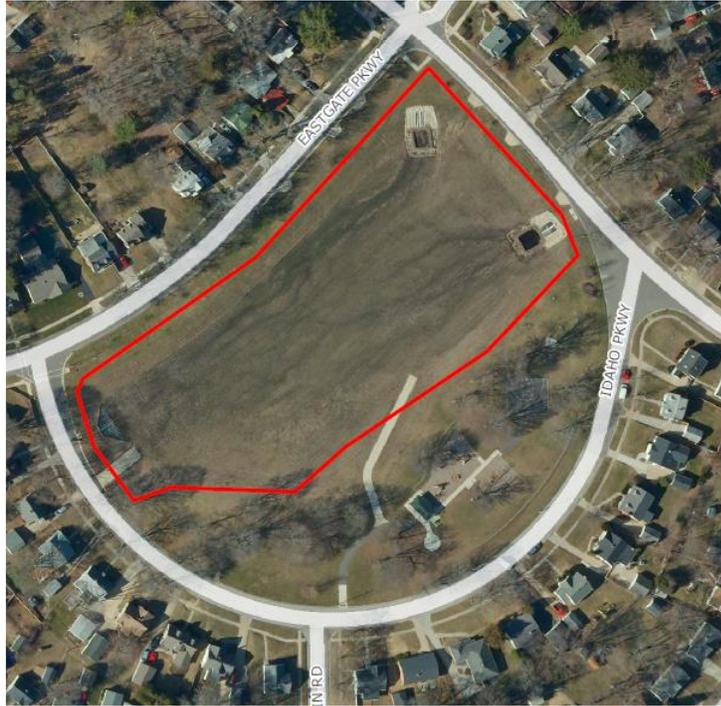
Location: Executive 1924 East Gate Parkway

Maintenance Responsibility: Rockford Park District, City of Rockford maintains structures.

Year	Maintenance items
2016	Regional basin was built.
2017	Routine Mowing
2018	Routine Mowing

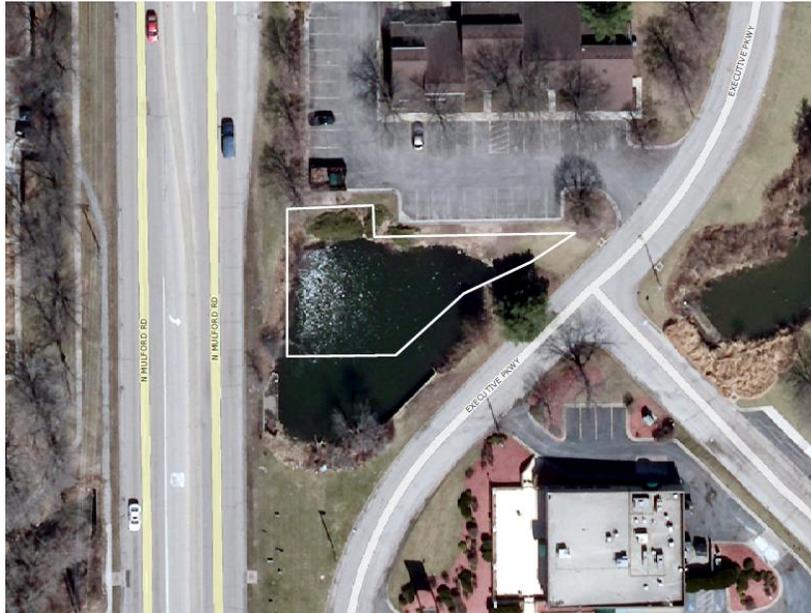
Location: Executive Parkway east of Mulford Road

Maintenance Responsibility: Mulford Village Office Park Owners Association

Year	Maintenance items
2013	Inspection indicated no immediate maintenance is needed.
2015	Inspection indicated no immediate maintenance is needed.
2016	Inspection indicated no immediate maintenance is needed.
2017	Association contacted to complete maintenance
2018	Routine Mowing

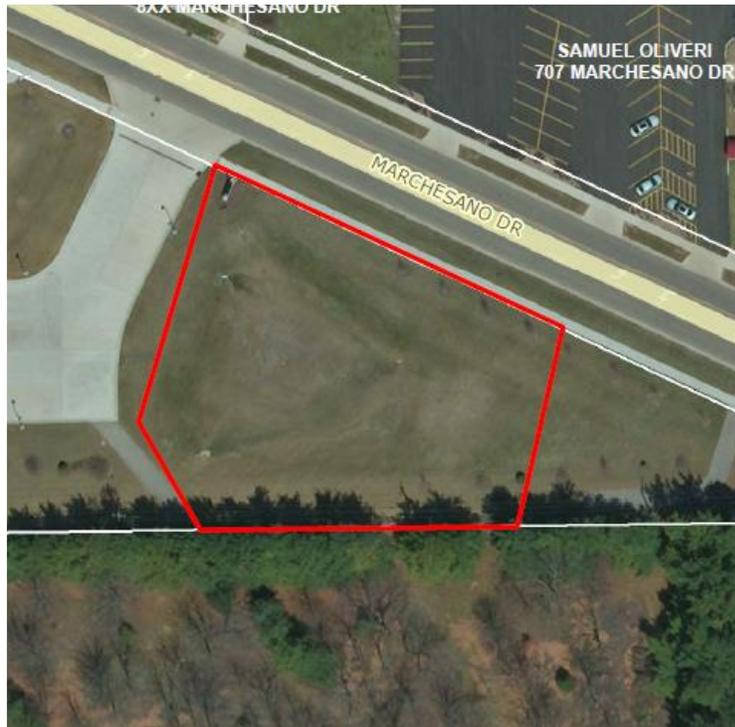
Location: 802 Marchesano Dr.

Maintenance Responsibility: City of Rockford

Year	Maintenance items
2015	Detention basin was built.
2016	Routine mowing
2017	Routine Mowing
2018	Routine Mowing

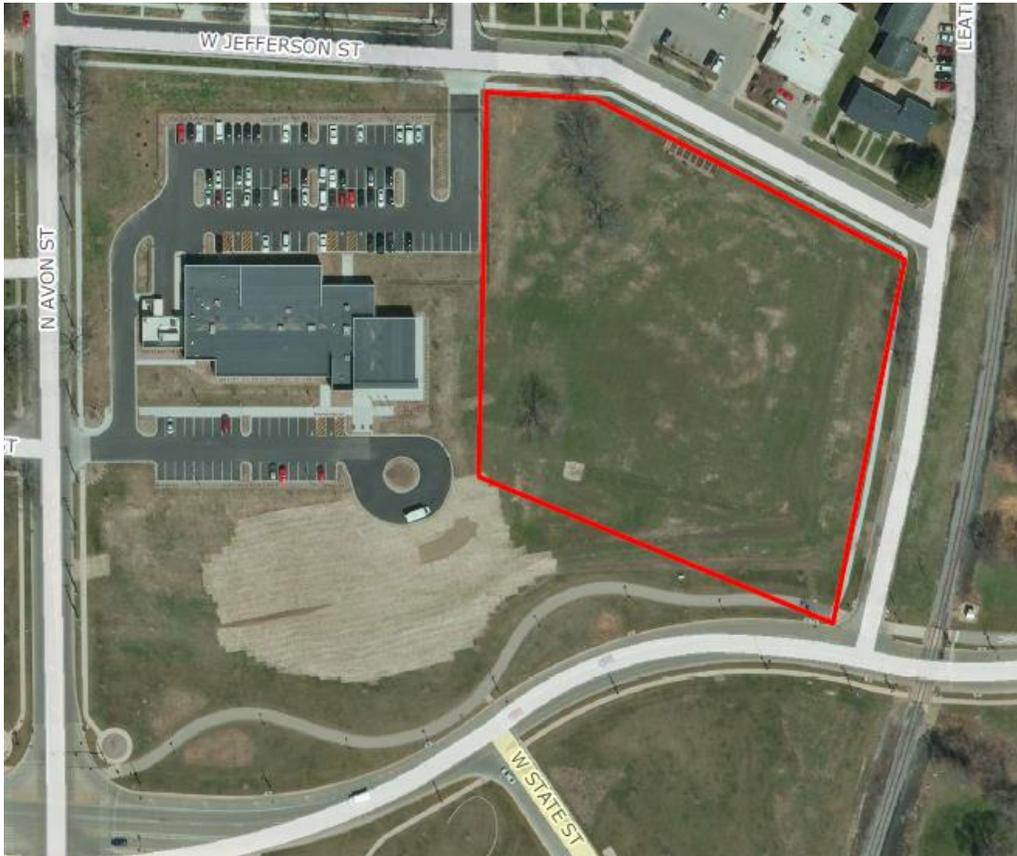
Location: 227 Avon St.

Maintenance Responsibility: City of Rockford

Year	Maintenance items
2016	Basin Built in 2016
2017	Routine Mowing
2018	Routine Mowing

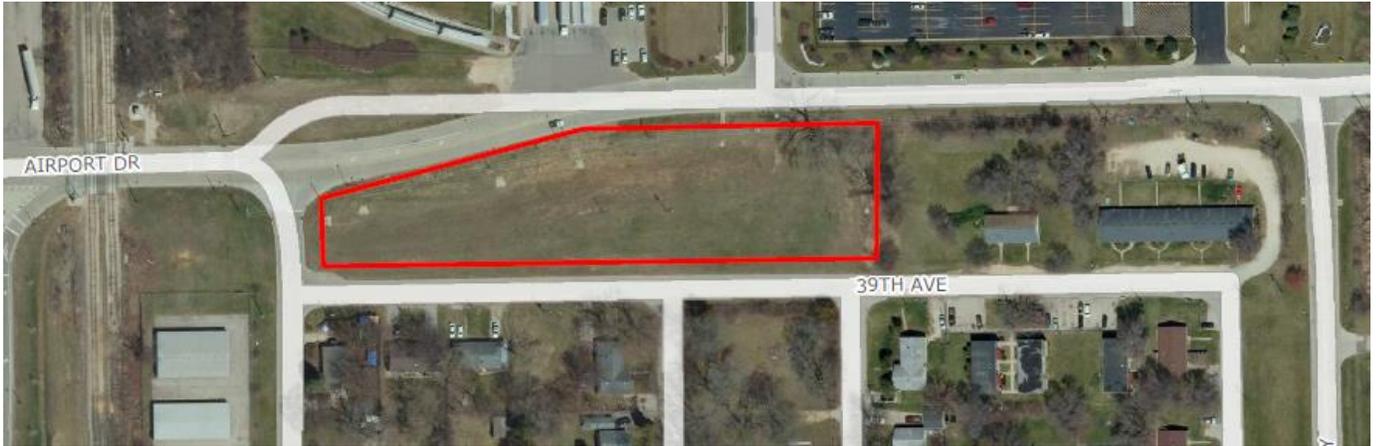
Location: 1004 39th Ave.

Maintenance Responsibility: City of Rockford

Year	Maintenance items
2016	Basin was built in 2016
2017	Routine Mowing
2018	Routine Mowing

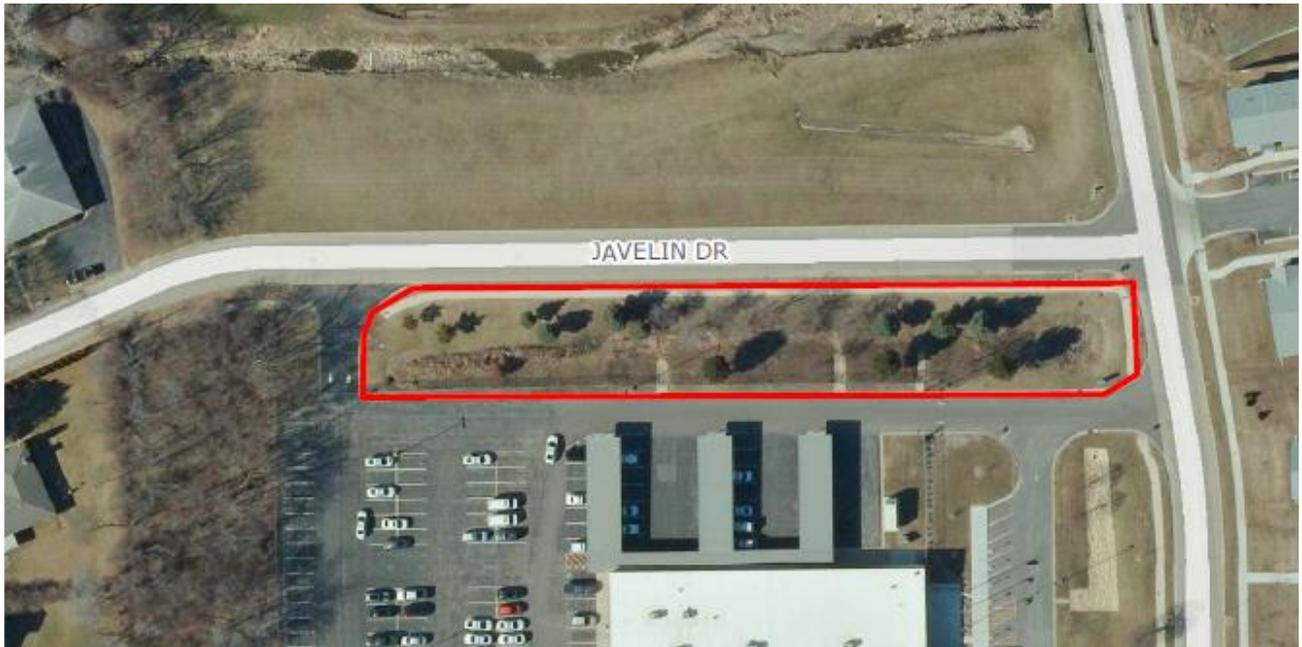
Location: 557 S. New Towne Dr.

Maintenance Responsibility: City of Rockford

Year	Maintenance items
2015	Routine Mowing
2016	Routine Mowing
2017	Trees cleared from basin & Routine Mowing
2018	Routine Mowing

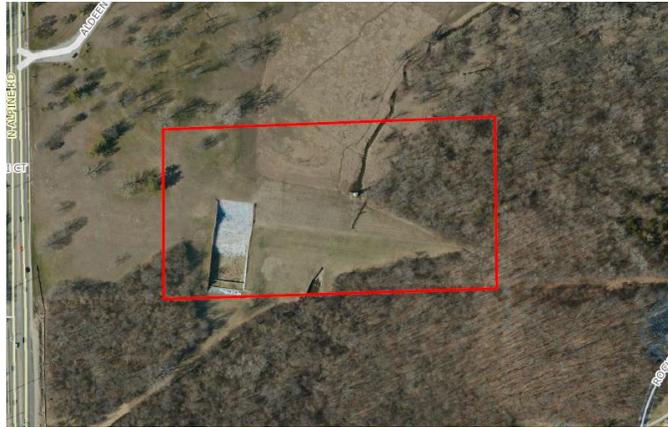
Location: 623 N. Alpine Road (Aldeen Park)

Maintenance Responsibility: City of Rockford & Rockford Park District

Year	Maintenance items
2012	Mowing of the embankments and removal of 70 tons of accumulated silt, debris, and floatables.
2013	Mowing of the embankments and removal of approximately 15 tons of accumulated silt, debris, and floatables from the trash rack. Erosion control work was also completed on the embankments where citizens walk up and down the slope.
2014	Replacement of handrails, mowing of the embankments and removal of approximately 38 tons of accumulated silt, debris, and floatables from the trash rack and spillway.
2015	Removal of approximately 17 tons of sediment and debris, mowing of embankments. Reseeded bottom of the basin with a native prairie mix.
2016	Routine Mowing & removal of approximately 11.5 ton of sediment & debris. New trash racks were also installed.
2017	Removal of approximately 3 ton of debris from the trash rack and routine mowing.
2018	Removal of approximately 6 ton of debris from the trash rack and routine mowing.

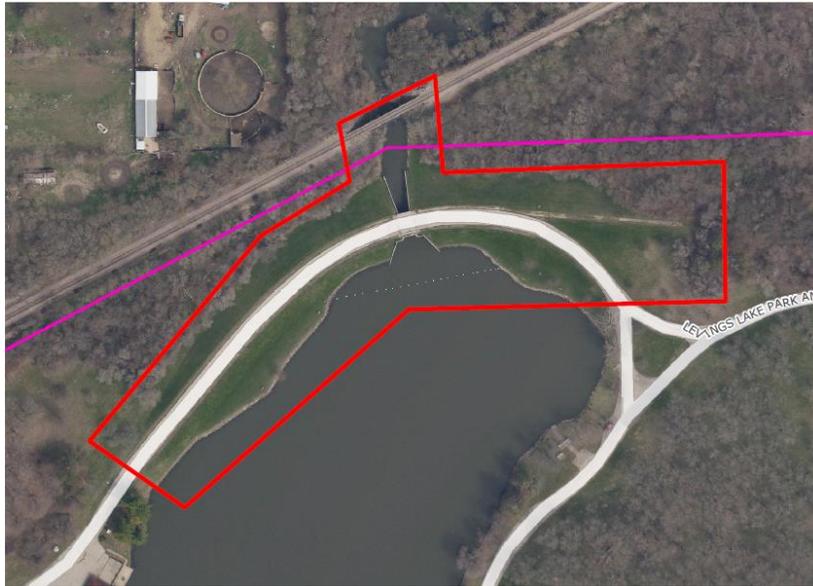
Location: South Pierpont Avenue (Levings Lake Park)

Maintenance Responsibility: City of Rockford & Rockford Park District

Year	Maintenance items
2012	Routine mowing of the embankments.
2013	Routine mowing of the embankments, repairing the cable buoys and filling and reseeding washouts along the dam structure.
2014	Routine mowing of the embankments. The City installed a depth gauge.
2015	Routine mowing, tree and brush removal at the toe
2016	Routine mowing, tree and brush removal at the toe. Silt removal at the inlet of the lake
2017	Routine Mowing
2018	Routine Mowing
